# **A HERITAGE RESOURCE ASSESSMENT FOR THE HISTORIC ARROWHEAD TOWNSITE AND CEMETERY, ARROWHEAD, BRITISH COLUMBIA**

**January 15<sup>th</sup>, 2009**

**HORIZON**  
HERITAGE CONSULTING

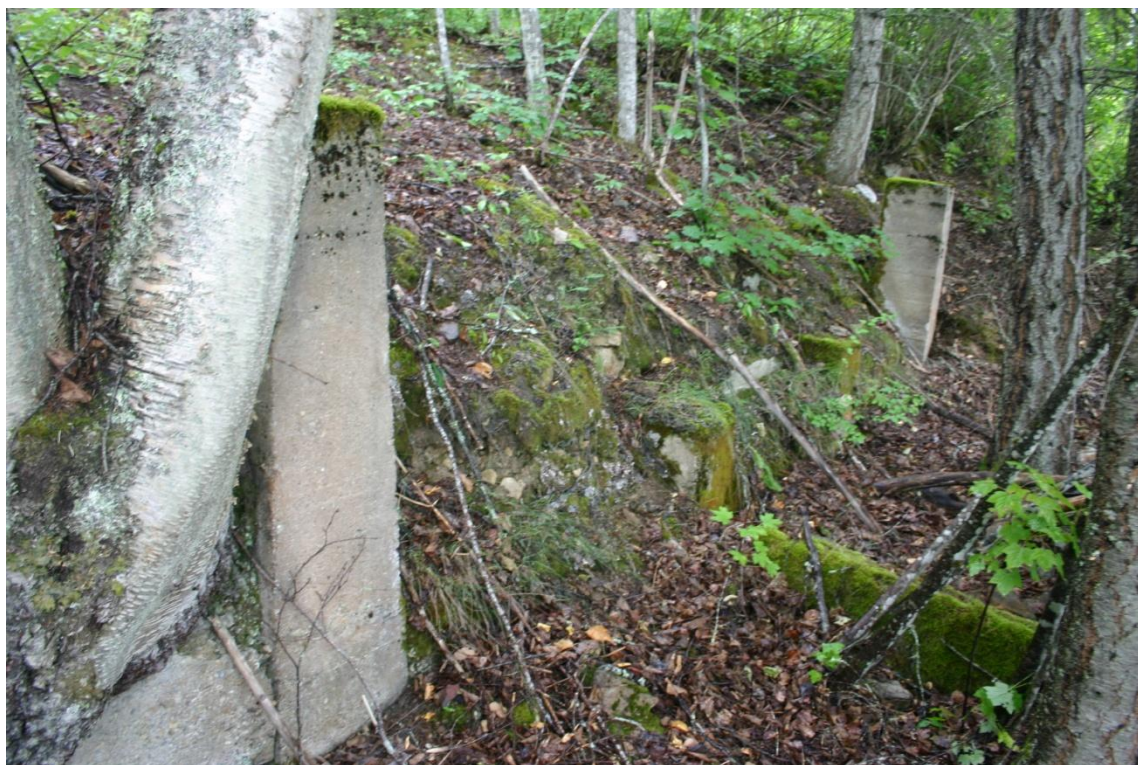
The site of the Imperial Bank is made obvious by the remains of concrete foundations at what would likely have been the rear of the bank, while the original location of the front of the bank along Front Street has been destroyed by inundation. The foundation consists of a series of five concrete pillars oriented in an E-W line along the back of the building. The pillars are six feet tall, 12" square at the top, flare out to 16" at the base, and are connected along the ground by a concrete retaining wall 2' high and 12" wide. The two westernmost and the easternmost column are still standing, while the other two columns have collapsed just above the two-foot retaining wall. The remaining columns are threatened by slumping and creeping soils coming down the slope from behind the structural remains from the north, and by encroaching vegetation. A very large paper birch tree is growing over the retaining wall between the two western columns (see Figure 12) and could damage them when it dies and falls, and the eastern column is already leaning in as a result of pressure from uphill deposits.

**Figure 12.** View east of the rear of the bank, showing standing and broken columns, the retaining wall, and a portion of the large birch tree growing on top of the wall.

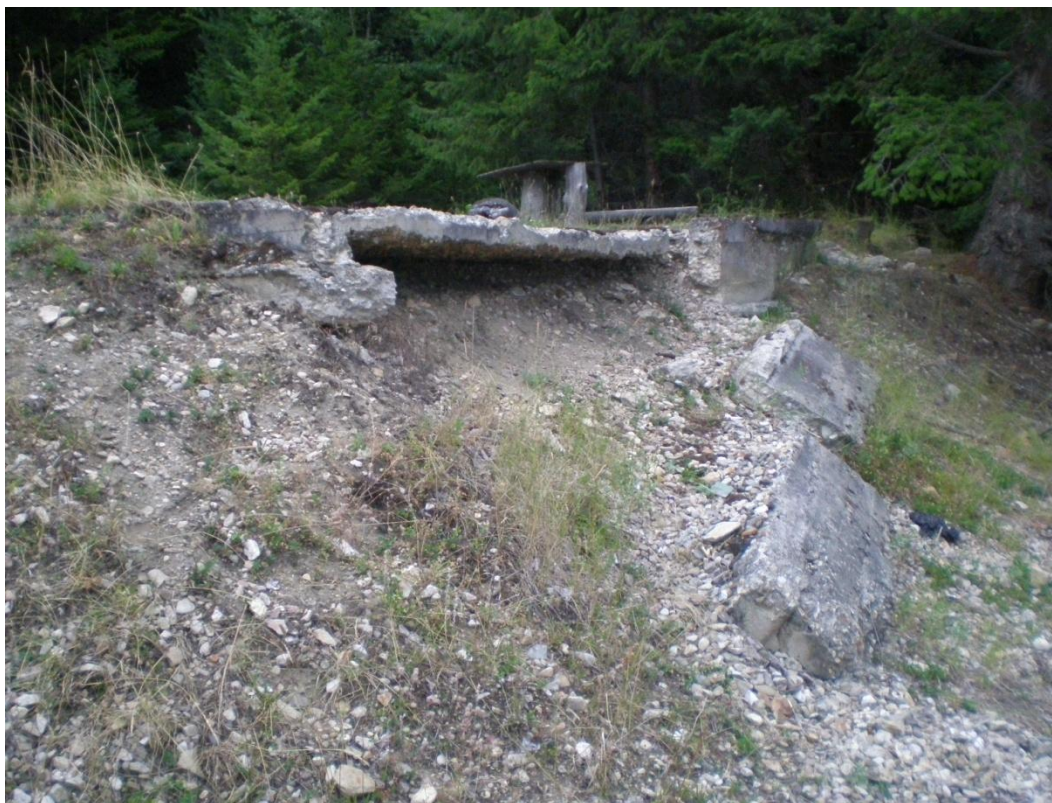
**Figure 15.** The edge of the concrete slab and retaining wall which were at the front of the City Hotel along Front Street, eroded by the elevated reservoir.

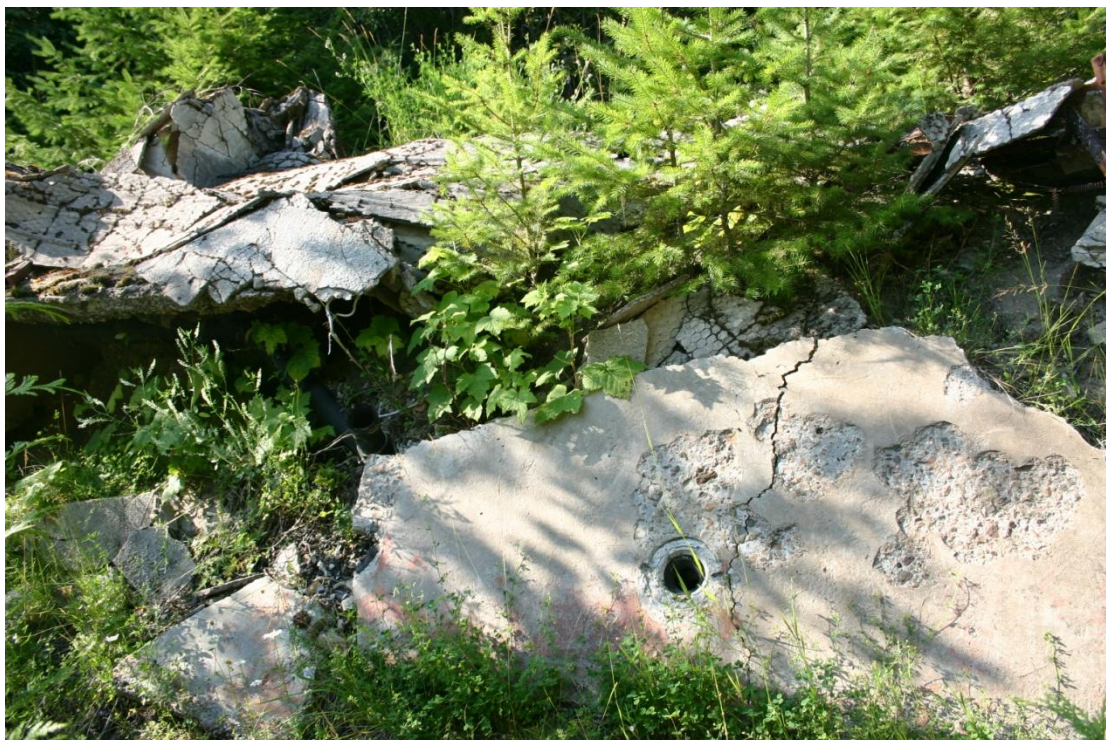
**Figure 29.** A portion of the collapsed concrete slab at the rear of the building. At least three additional floor drains were plumbed into the 4" slab.

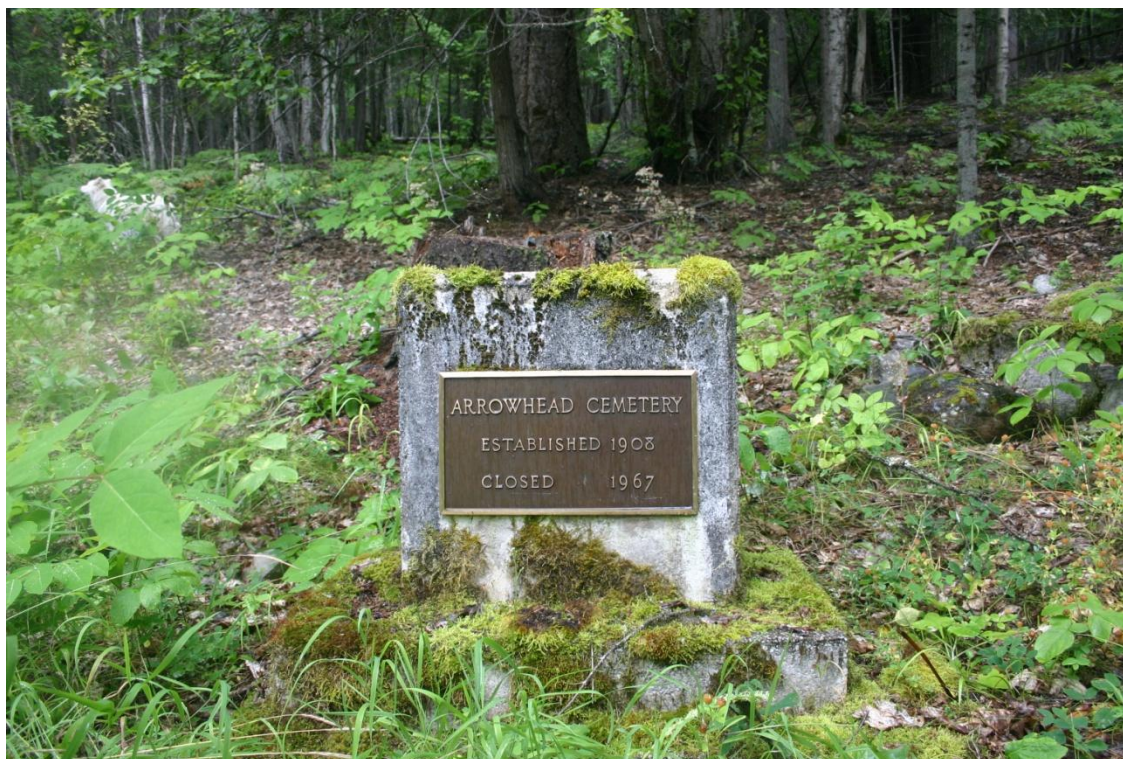
**Figure 40.** Marker placed at the cemetery in 1967. Slightly askew due to erosion.

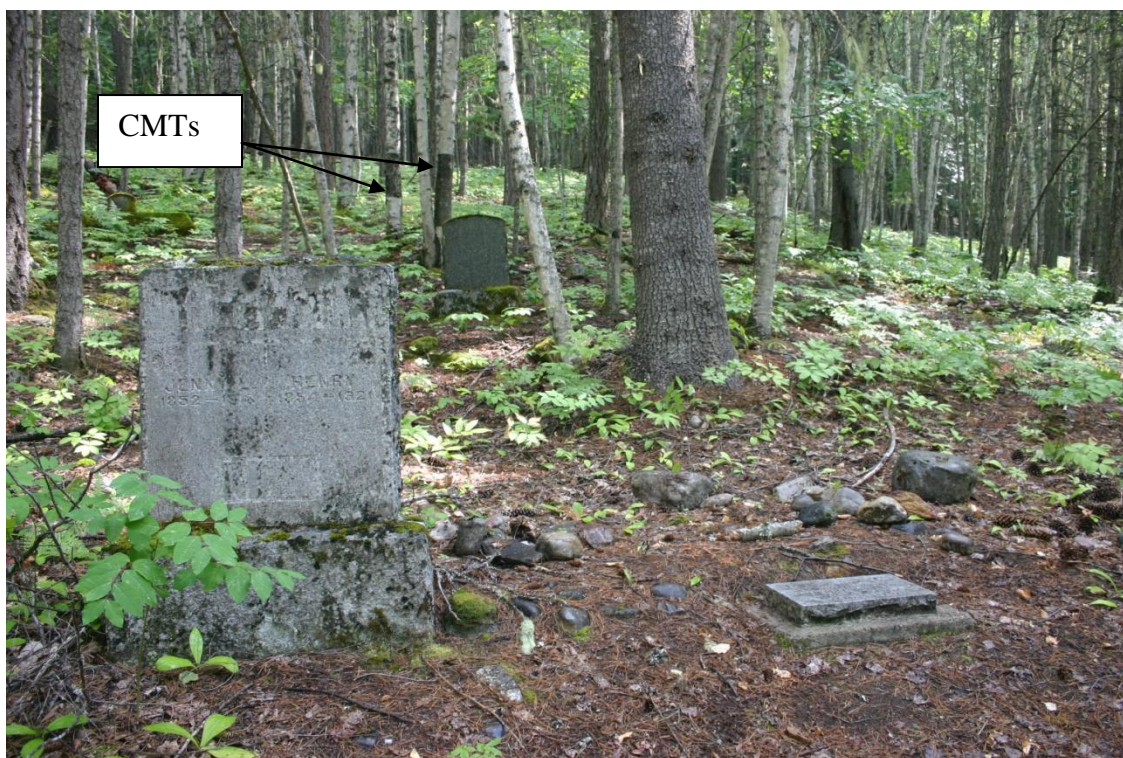
**Figure 41.** A general view of a portion of the cemetery, view east. Plot 276 (Kirk) in foreground. Note upright stones askew due to erosion, exposure of concrete around flat marker, displaced cobbles, leaning fir and birch trees, and bark-stripped birch CMTs (see Section 3.5).

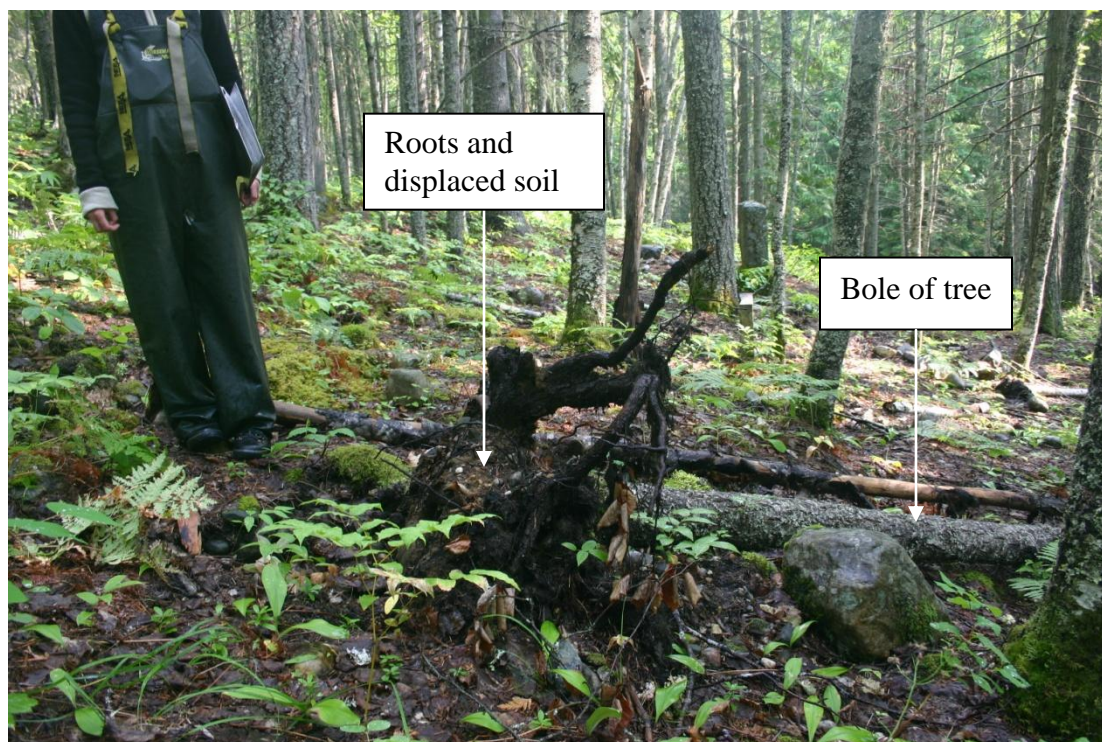
**Figure 42.** A 'tree throw' in the cemetery. This is a relatively small tree which has not displaced a large amount of soil, but larger trees at the cemetery have the potential to displace large amounts of soil and interred human remains.

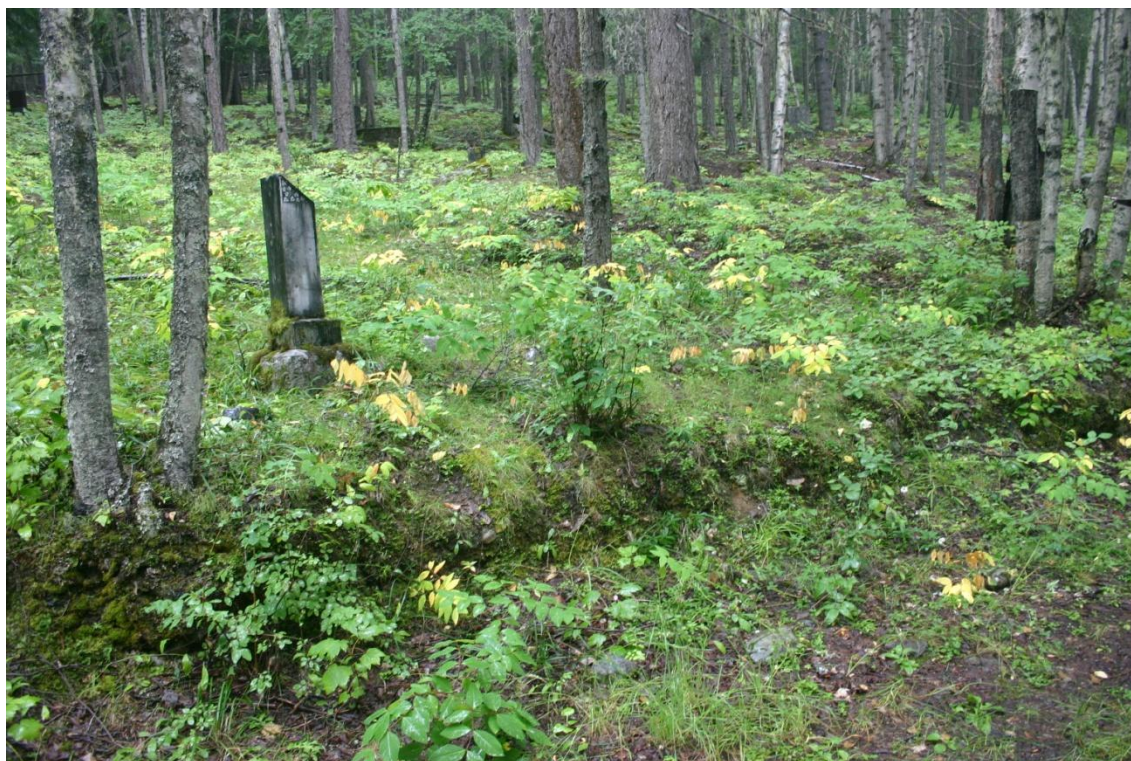
**Figure 43.** Plot 'C' (Holbert 1907) – very close to road cut, threatened by bank erosion. Note CMTs at right.

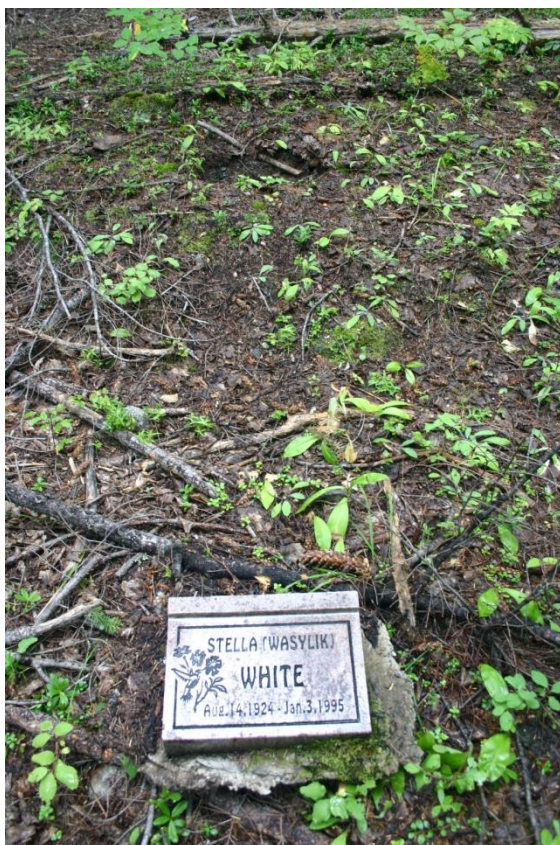
**Figure 44.** Plot 224a (White). This marker was dug up and displaced 5 metres by a bear digging into a buried termite nest under the stone. The hole from which it was displaced is visible near the top of the photo.

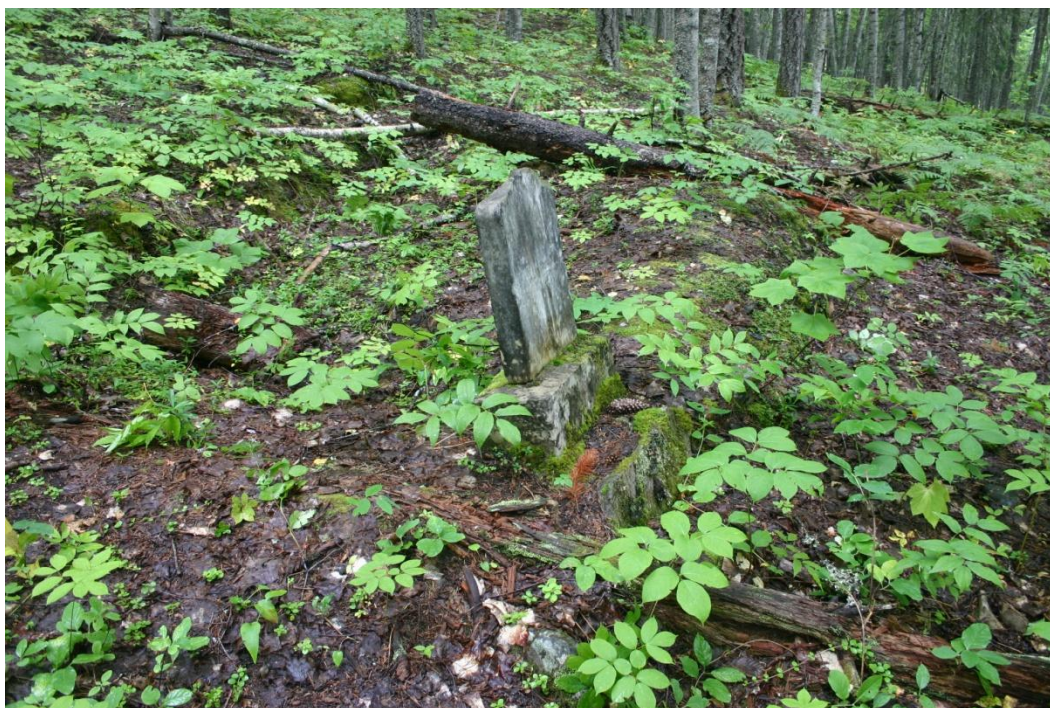
**Figure 45.** Plot 248 (Nelson). The stone is being displaced by soil creep and erosion. The top of the stone has been broken, likely by the fallen log in the foreground which has now nearly rotted away. A more recent fallen log lies in the background.

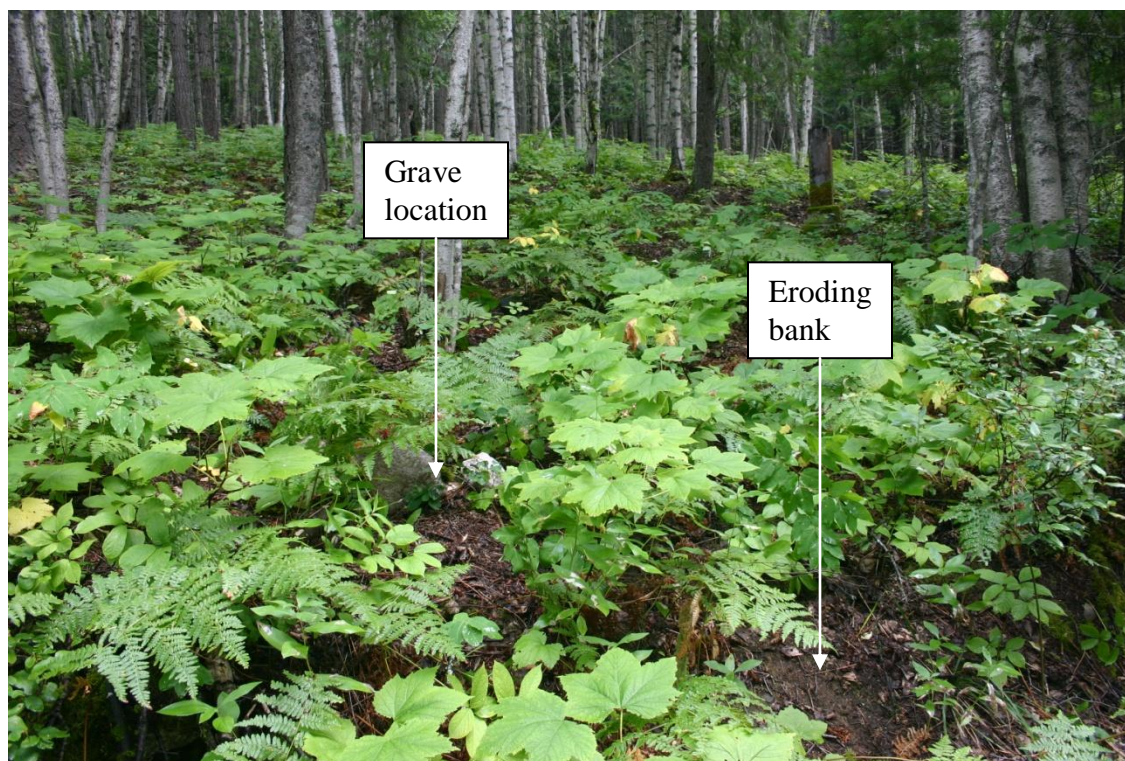
**Figure 46.** Plot 261 (Butler child). The grave is only visible as a slight depression with a few cobbles, and is in imminent danger of eroding out of the road cut bank.

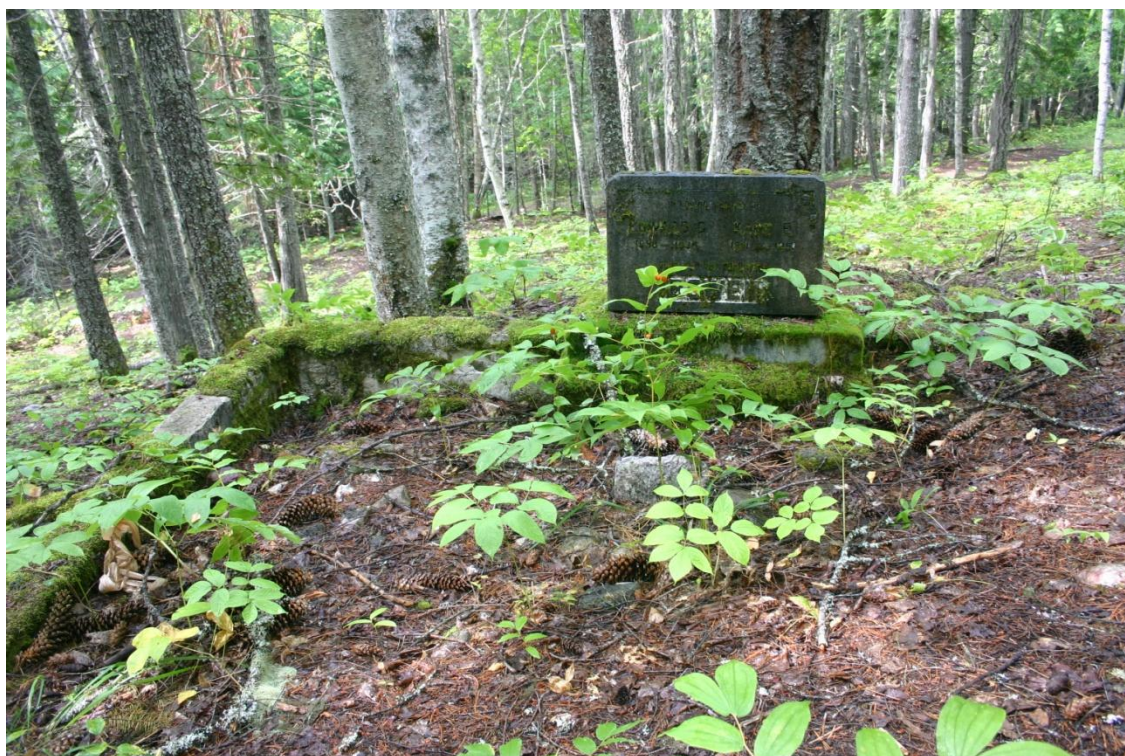
**Figure 47.** Plot 265 (Bowen). Note severe erosion which has displaced a large amount of soil from inside the retaining wall, and the crack under the stone which is separating from the concrete foundation.

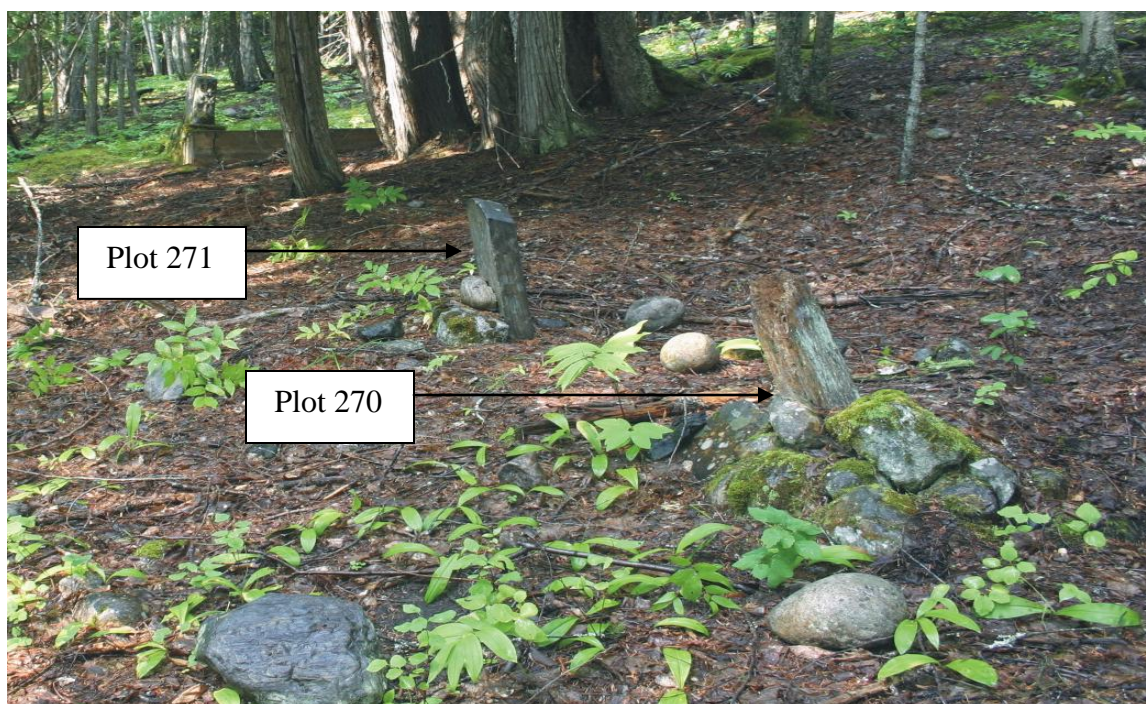
**Figure 48.** Plots 270 (Heffern) and 271 (Gibbs). Gibbs' stone has broken from its pedestal and is propped up by a cobble. Heffern's wooden marker is badly rotted.

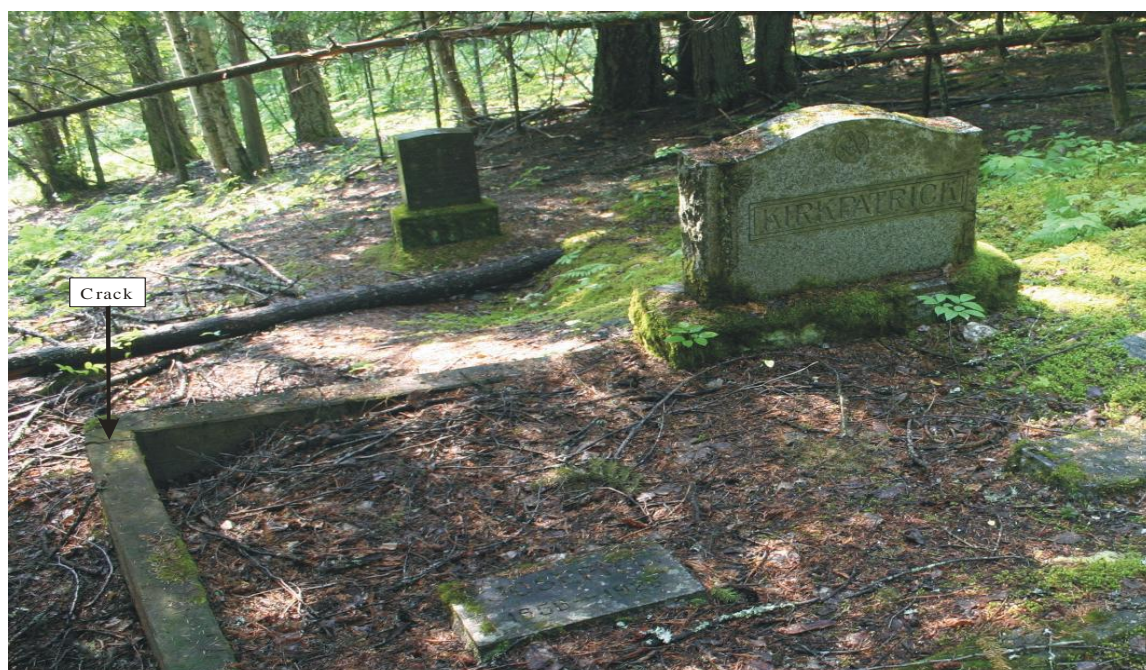
**Figure 49.** Plot 271a,b,c (Kirkpatrick) showing displacement of soil by erosion inside the retaining wall. The visible crack goes right to the ground and is widening.

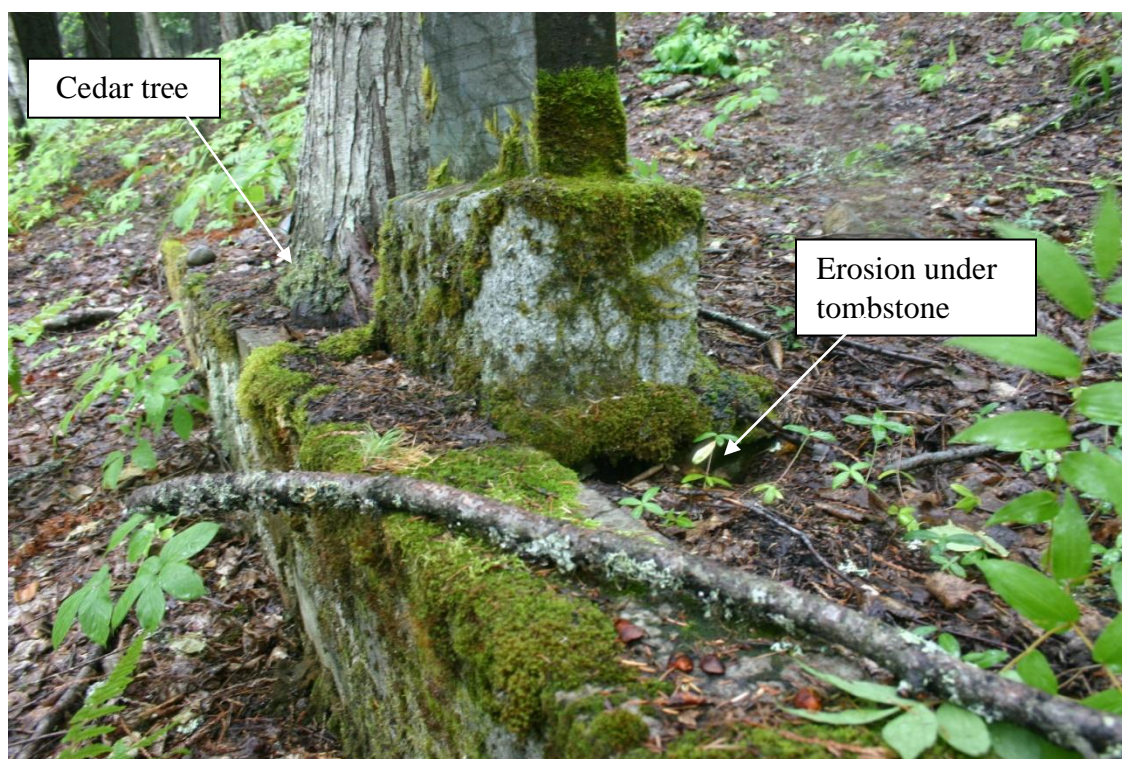
**Figure 50.** Plot 286 (Johnson), showing undermined tombstone and cedar tree growing over cracked and leaning concrete retaining wall.

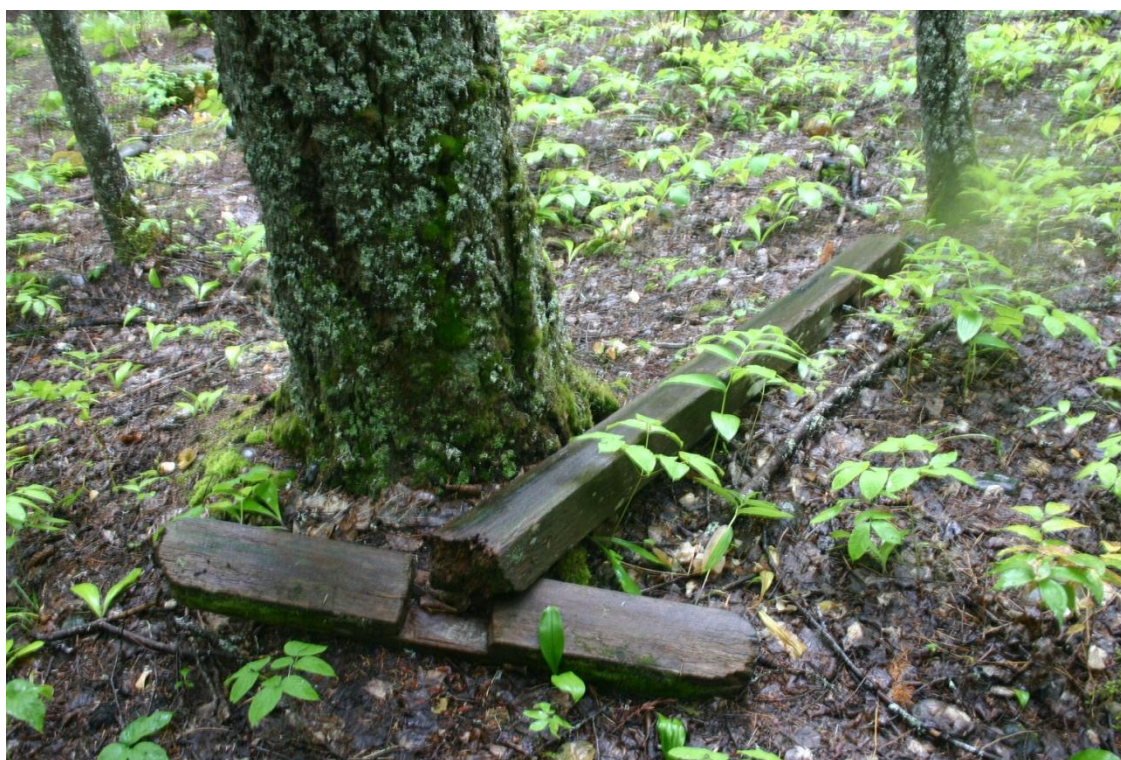
**Figure 51.** Fallen wooden cross at Plot 289S (Armstrong).

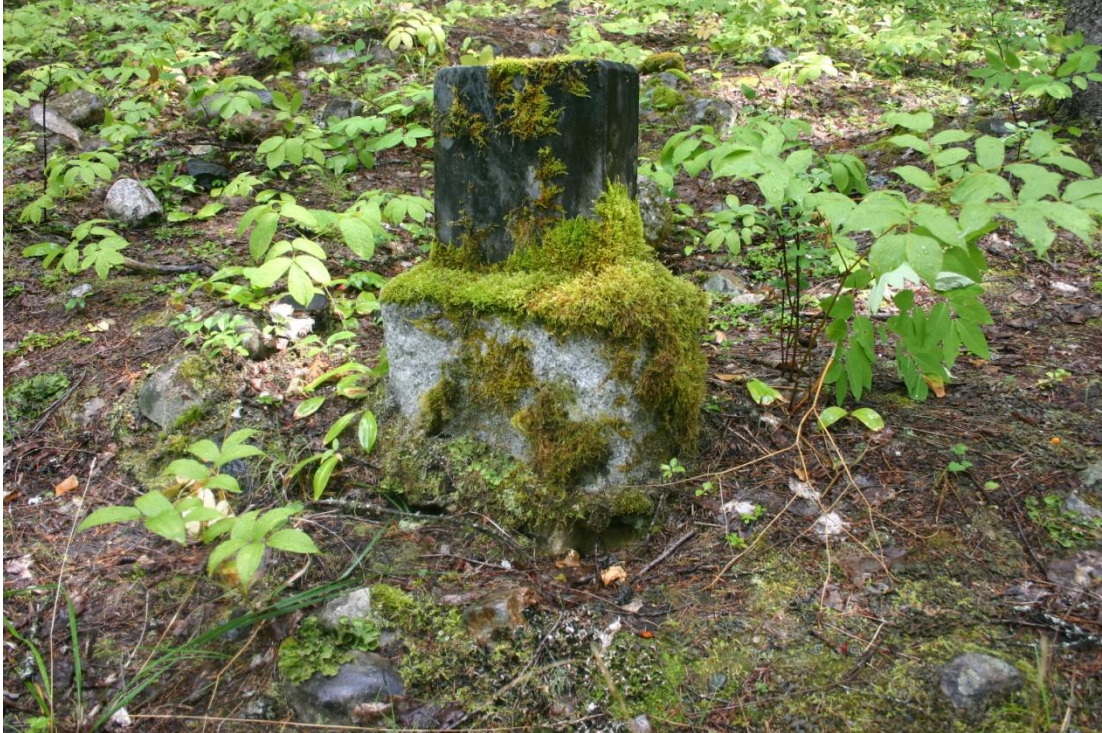
**Figure 52.** Plot 298S (Vaughn). Marker is being undermined by erosion and could soon topple.

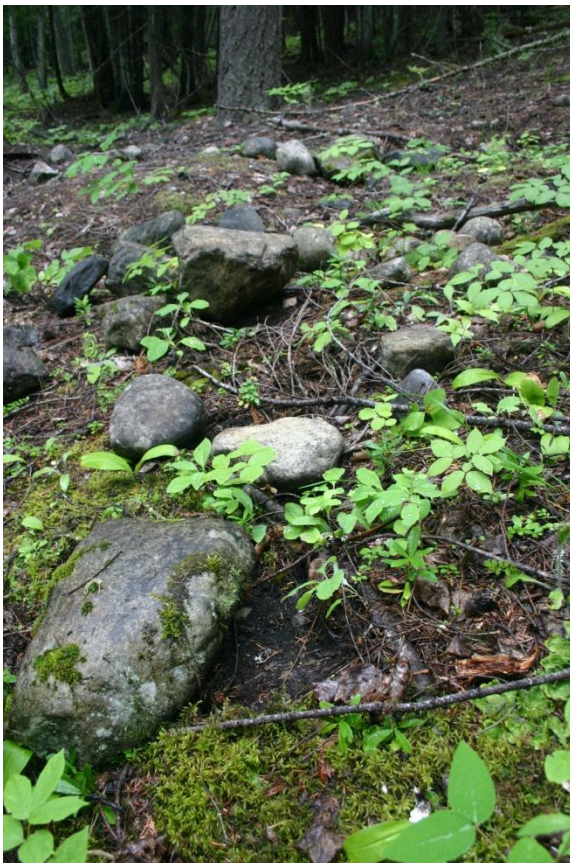
**Figure 53.** Cobbles in the vicinity of Plots 250a, b, and c (McQueen, Boyd, and Athol). The original arrangements have been severely displaced by foraging bears, and several have been overturned very recently, as seen with the cobble in the foreground.
