# **A HERITAGE RESOURCE ASSESSMENT FOR THE HISTORIC ARROWHEAD TOWNSITE AND CEMETERY, ARROWHEAD, BRITISH COLUMBIA**

**January 15<sup>th</sup>, 2009**

**HORIZON**  
HERITAGE CONSULTING

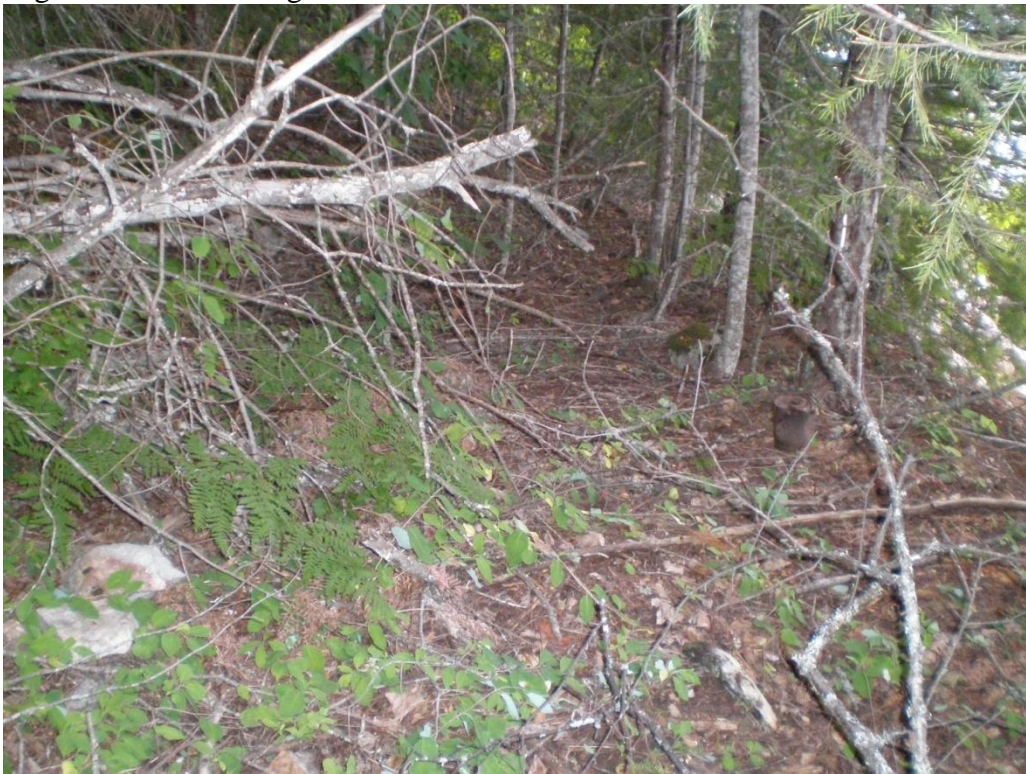
Historic artifacts were observed in block 1 below the current high water line and in the remaining 5 by 7 metre building footprint. Mason jars, a wall flange for a wood stove pipe, camping fuel tins, and food tins were observed within the footprint, including hole-in-top lead soldered cans (see Table 2). Rotten dimensional lumber fragments were present in the mossy ground cover, and a portion of a cobblestone retaining wall exists along the back of the building footprint. Bottle glass and galvanized sheet metal fragments were eroding out of the bank below.

**Figure 6.** Remains of the only visible building footprint in Block 1. View east.

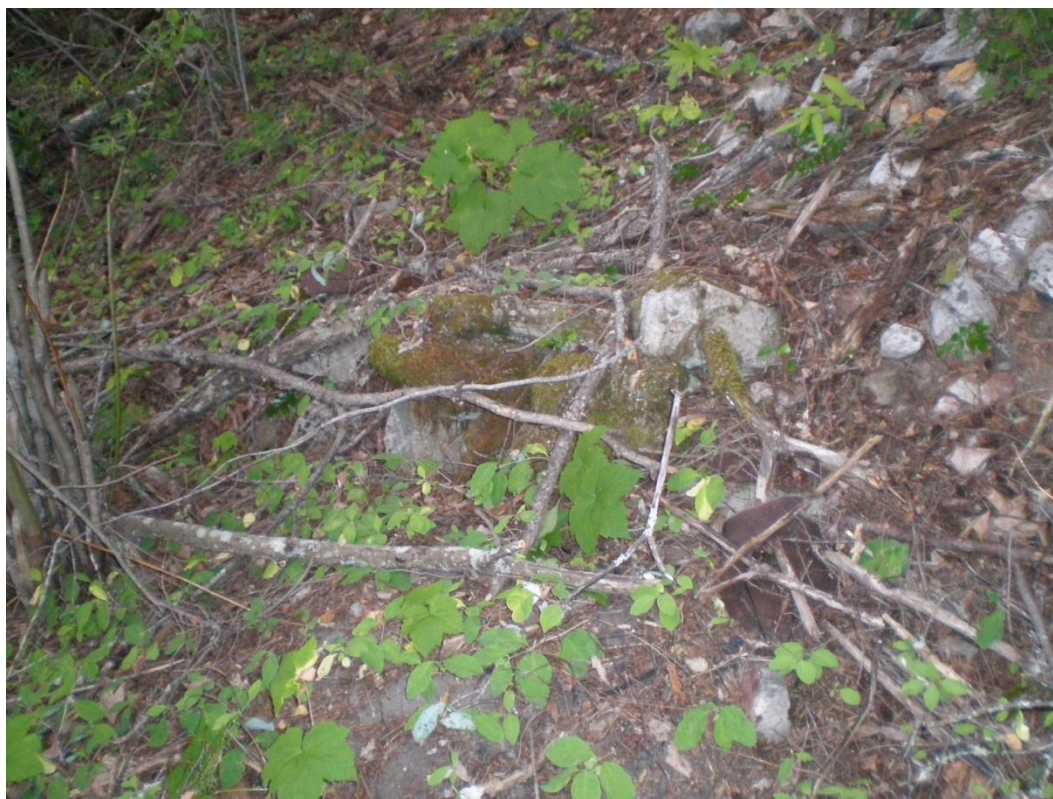
**Figure 7.** The remains of a stone retaining wall at the rear (north side) of the footprint.

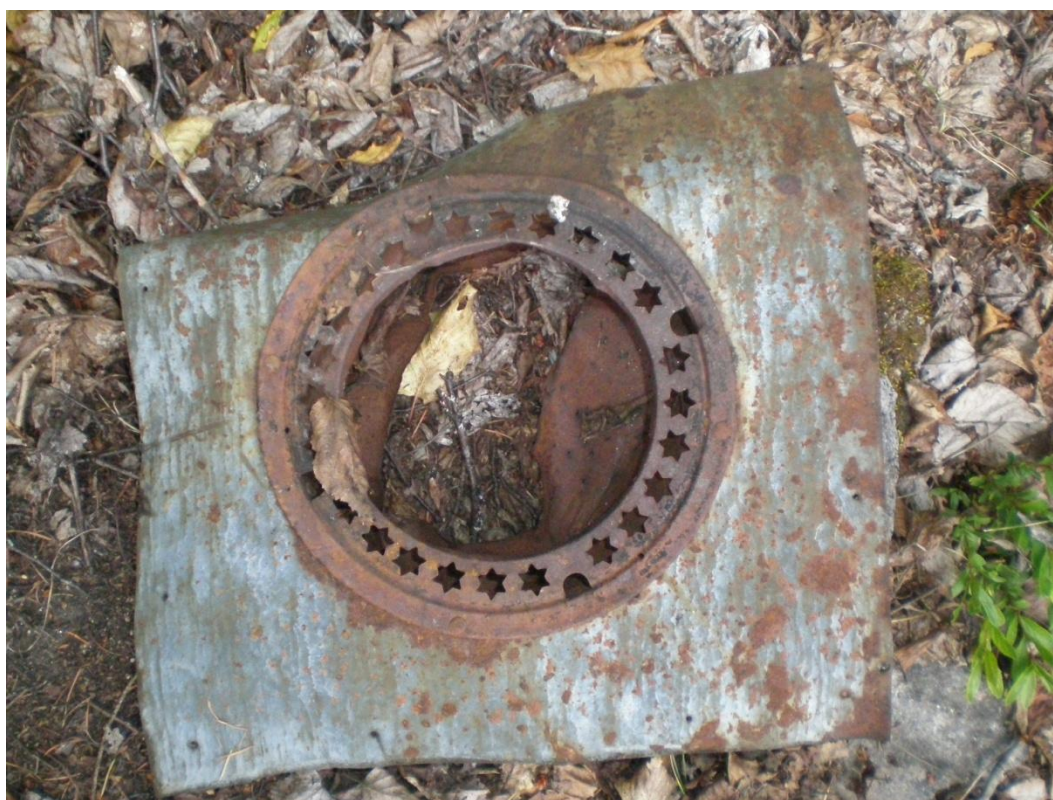
**Figure 8.** A metal stovepipe flange found near the building footprint in Block 1.

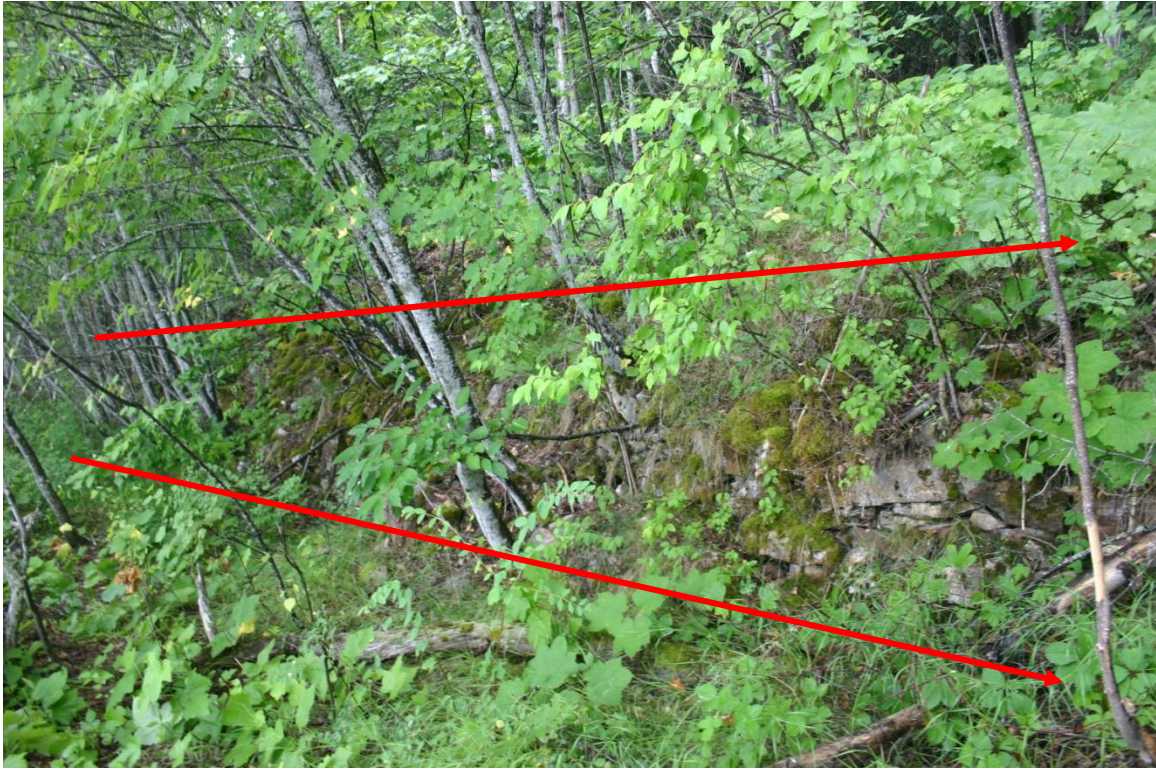
**Figure 9.** The remains of a stone retaining wall along the Block 2 alley.

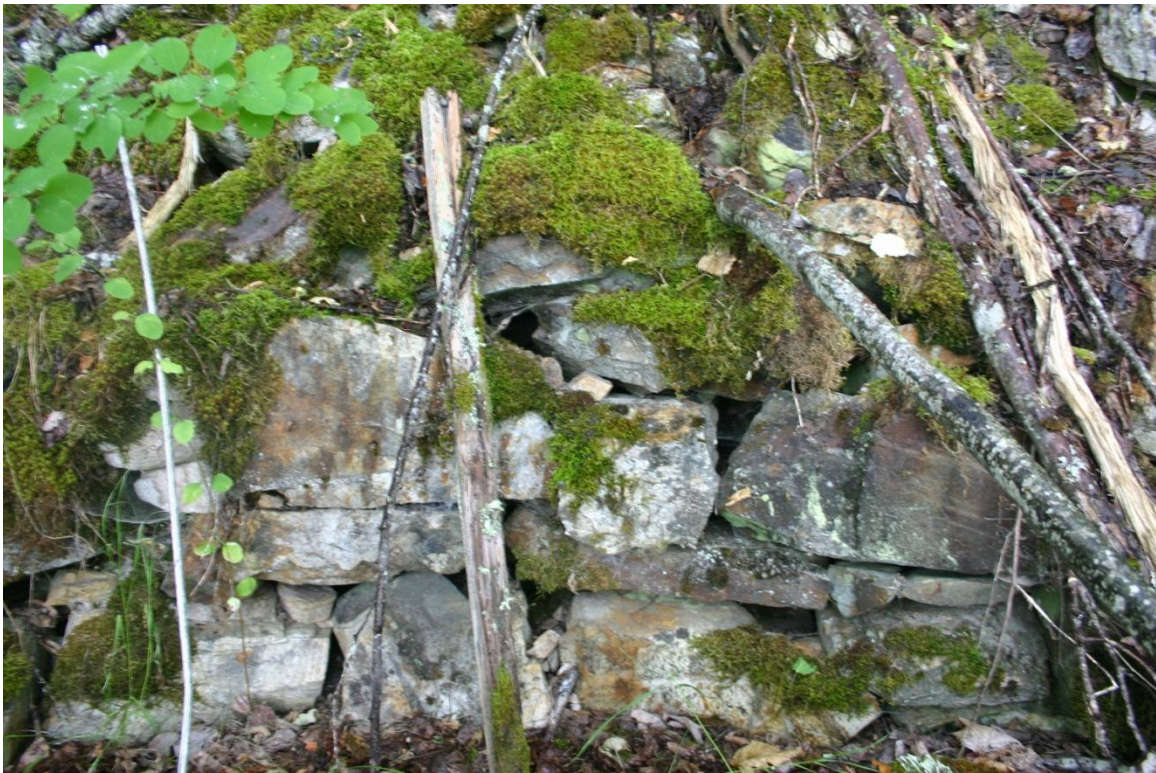
**Figure 10.** Blocks of local stone were stacked but not cemented to create the wall. A piece of weathered dimensional lumber (3/4" x 3.5" x 4') is leaning against the wall in the centre of the photograph.

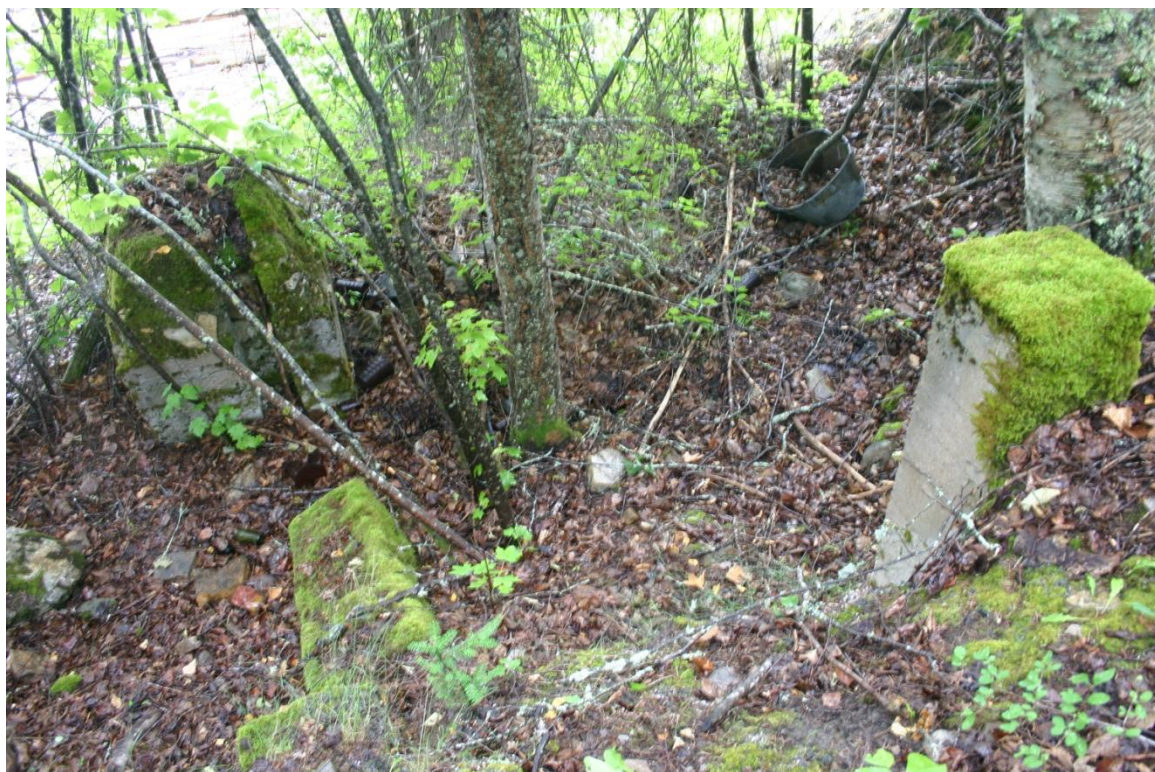
In the centre of the remaining footprint of the bank is a large block of concrete, 1 metre square and 1.5 metres high, which was formed with shiplap and tapers towards the top (see Figure 11). The lower portion of the block appears to have regular aggregate, while the upper portion has large cobbles cemented in. The bank's vault may have originally sat on top of this block.

**Figure 11.** View south from the rear of the Imperial Bank, showing the large block of concrete (vault pedestal?), standing and broken columns, and various artifacts.

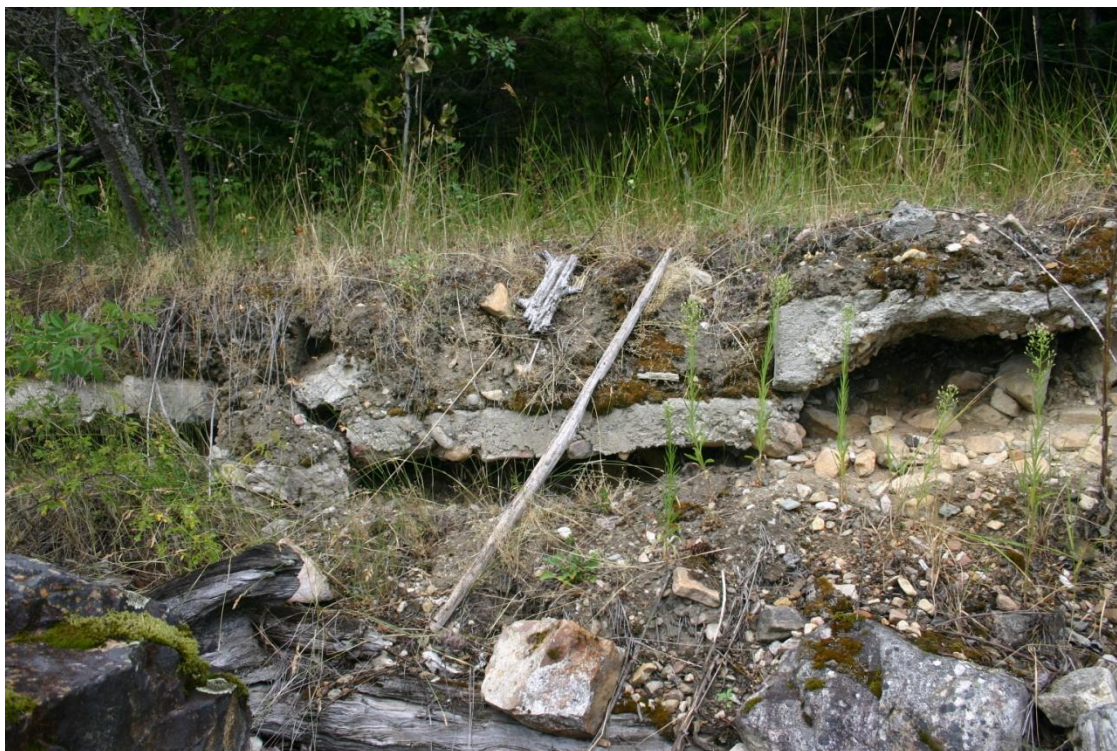
At the front (south side) of the clearing is a cut bank along the current high water mark, where the remnant of a concrete sidewalk 20 centimetres thick and 6 metres long is visible (see Figure 13). At the east end of the sidewalk there is a single concrete step down. This sidewalk was likely once at the front of the Lakeview Hotel, with a step down onto what was once Front Street. The sidewalk is now covered with 10-30 centimetres of fill. This fill is very dark in colour which suggests a high organic and/or charcoal content, and is probably made up of the remains of the hotel itself after it was destroyed and burned. Small pieces of rotten dimensional lumber and charcoal were observed eroding out of this dark layer.

**Figure 13.** Buried concrete sidewalk and step down in front of the former Lakeview Hotel.

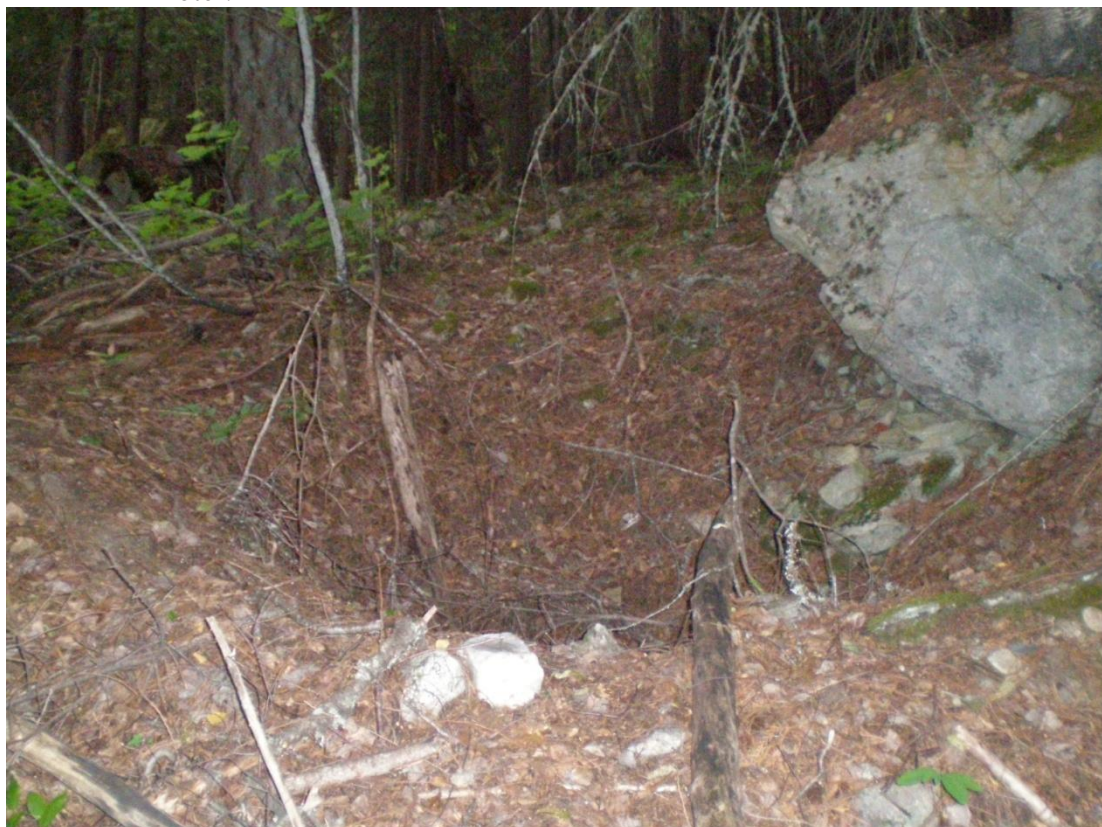
Above the refuse dump approximately 3 metres up the slope is a large hole, approximately 1x1 metre and 1.5-2 metres deep (see Figure 14). The sides of the feature had slumped in so it was difficult to determine its exact depth. This was possibly the site of an outhouse behind the hotel which would have been easily accessible via a back deck on the second floor, over which much of the refuse could also have been dumped.

**Figure 14.** The depression behind the site of the Lakeview Hotel, possibly the site of a former privy.

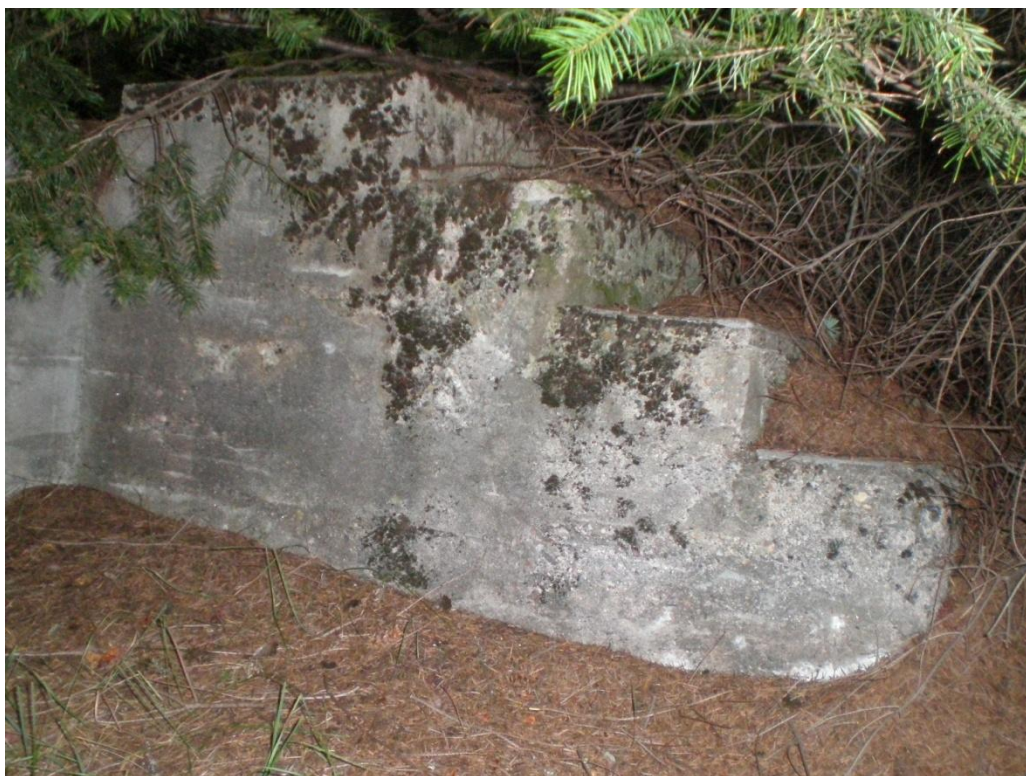
**Figure 16.** Steps leading from the City Hotel east down onto 3<sup>rd</sup> Street.

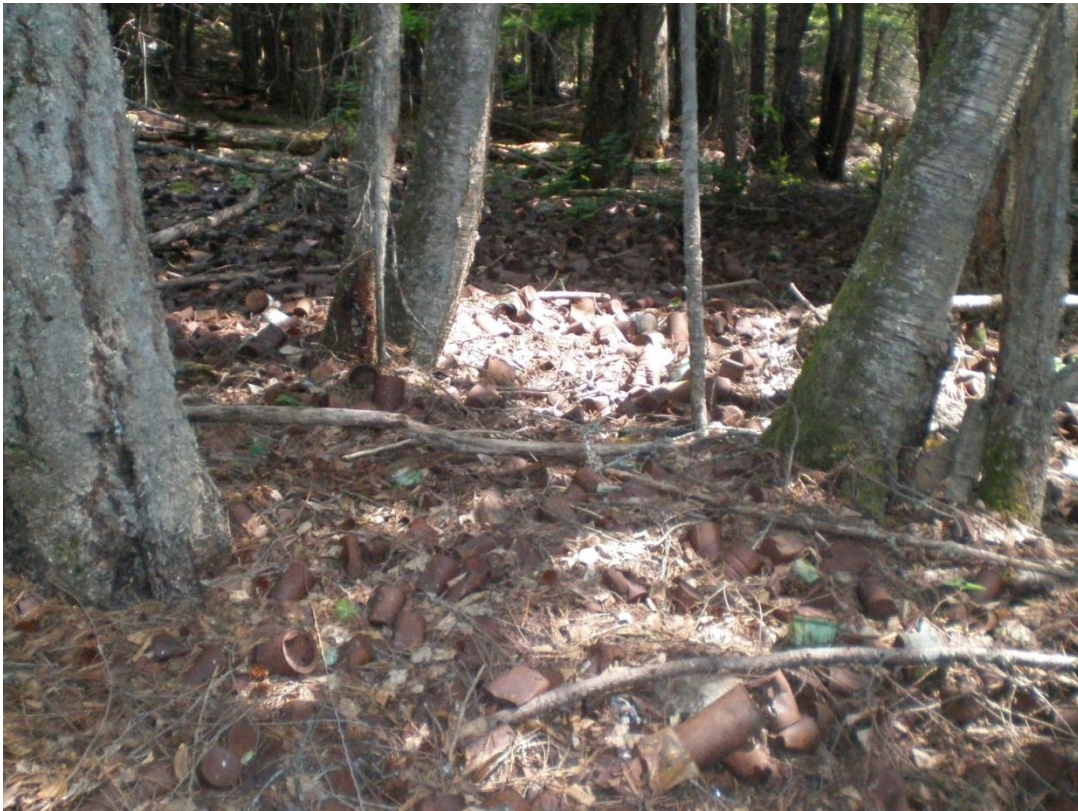
Within and to the east of the church site is a massive historic garbage dump, with thousands of food tins and various other refuse spread over a 30 m N-S by 50 m E-W area (Figure 17). Notable items include hole-in-cap cans, hole-in-top cans, mason jars, tobacco tins, glass jars, window glass, dimensional lumber, and even a railroad tie. Branded items include Red Rose Coffee tins, large (5 gallon) Mazola oil tins, Oxo tins, Prem meat tins, Johnson's Wax, Nabob Baking Powder tins, Fry's Cocoa tins, a Red Devil Soot Remover tin, and several different brands of tobacco tins. There were also fragments of ceramic dishes, including a teacup fragment marked Made In England. The range of artifacts, from the hole-in-cap cans (pre-WWI) to the 'Zing' orange cola can with a pull tab (post-1962 – IMACS 2001:471) shows that this dump was used throughout the lifespan of the town, and the remarkable preservation of some of the specimens such as those with famous national brand labels listed above makes this a very significant collection of historic artifacts for historians and historical archaeologists interested in studying the early post-contact period of this geographically isolated region.

**Figure 17.** A portion of the Block 3 midden east of the Anglican Church site.

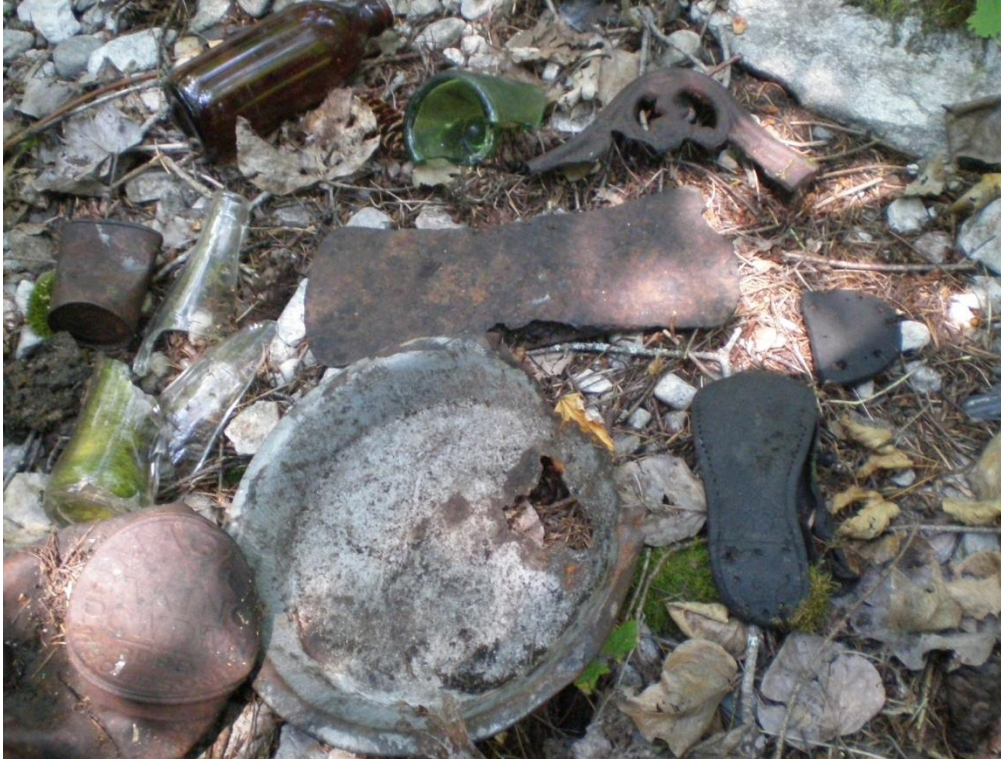
The Presbyterian Church sat on the corner of Lonsdale and 4<sup>th</sup> Streets, at the NE corner of Block 4. The building footprint is visible as a 20 x 20 metre level clearing below the former Lonsdale Street. Several historic artifacts were observed here (see Figure 18), including old style colourless glass Coca-cola bottles (first produced 1916), stubby beer bottles (used almost exclusively in Canada 1962-1986), food tins, an enamelware ferrous metal pie plate, an axe head, turn-mold bottles (1890-1910), leather shoe soles, a decorative cast iron fragment (possibly from a stove), a Magic Baking Powder tin (1897-1915), and a metal steering wheel.

**Figure 18.** Artifacts found at the former location of the Presbyterian Church.

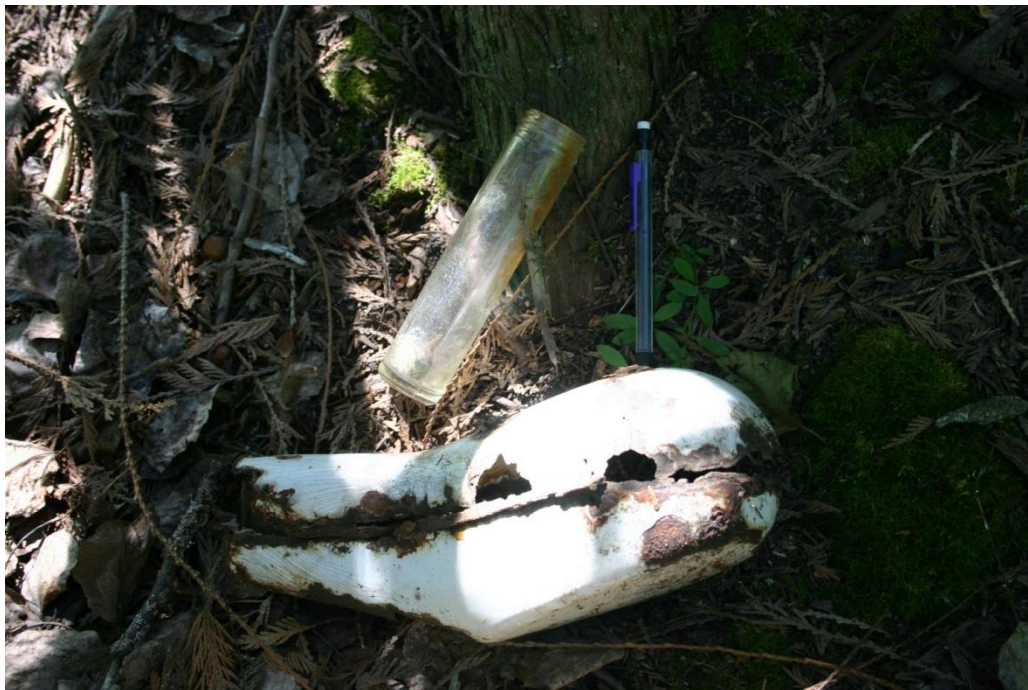
**Figure 19.** A glass Alka-Seltzer tablet tube and a hinged enameled metal bed warmer (?).

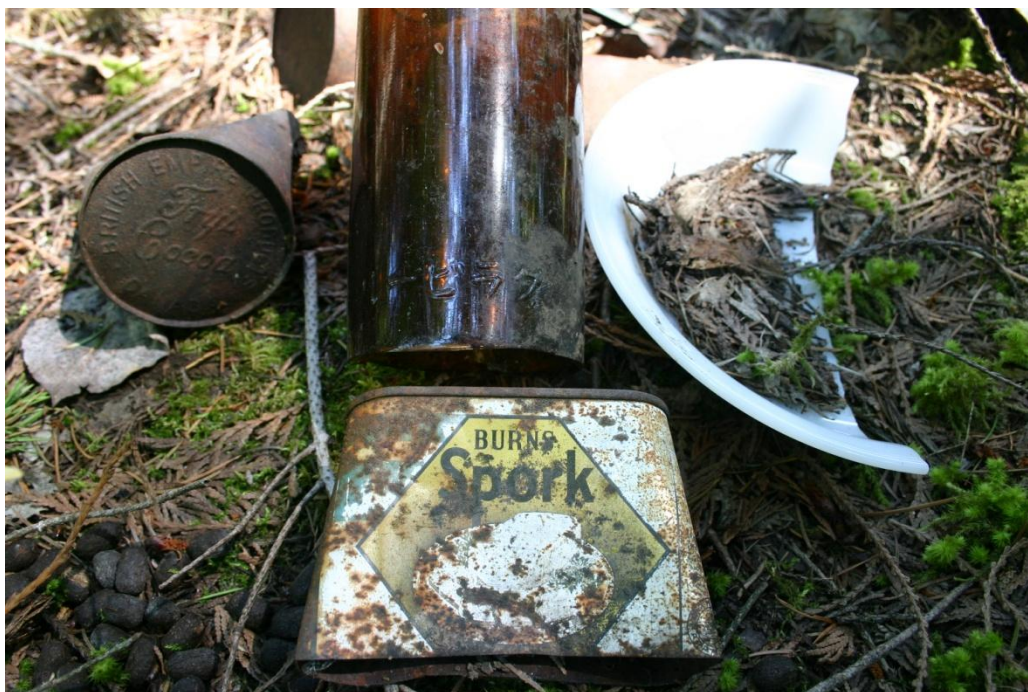
which may have been a bed warmer. Several metal bedframes were observed at the top of the gulley, along with many other domestic items such as metal pots and pans and various broken ceramic dishes. A brown glass beer bottle with moulded Japanese writing (Figure 20) was also found here (it had 'AKURA BEER' embossed on the opposite side).

**Figure 20.** Various items found in the Block A midden, including a Japanese beer bottle.

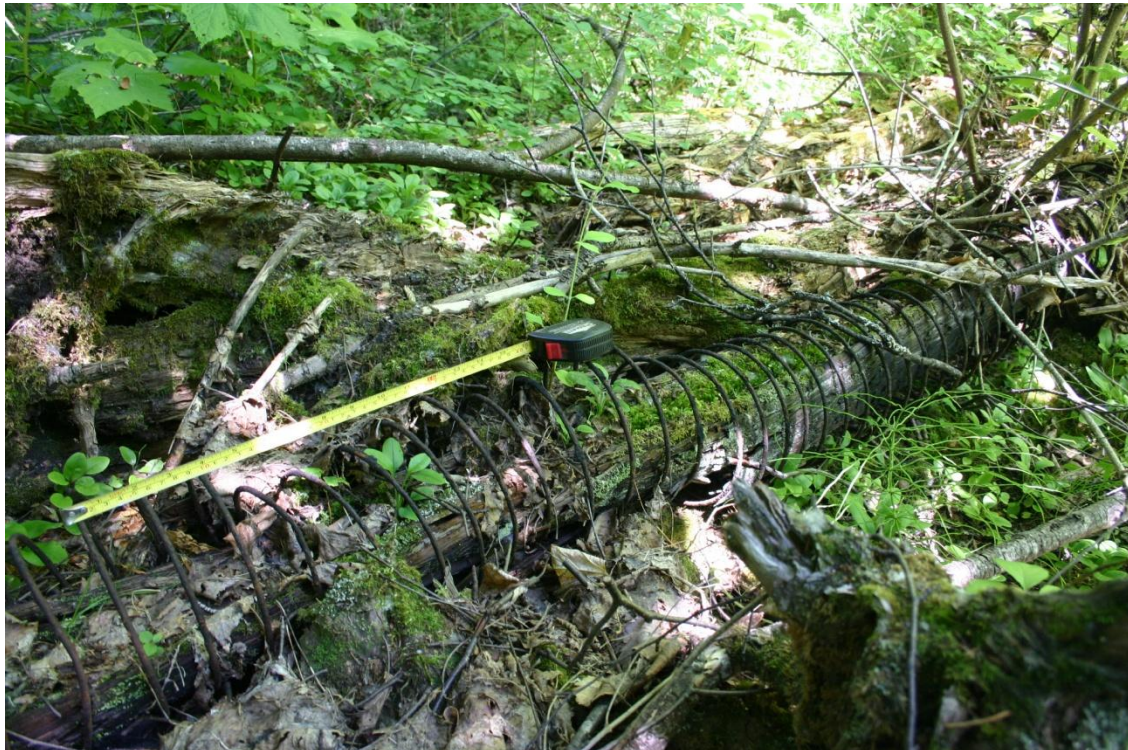
**Figure 21.** The remains of a wire-wrapped wooden water pipe in Block F.

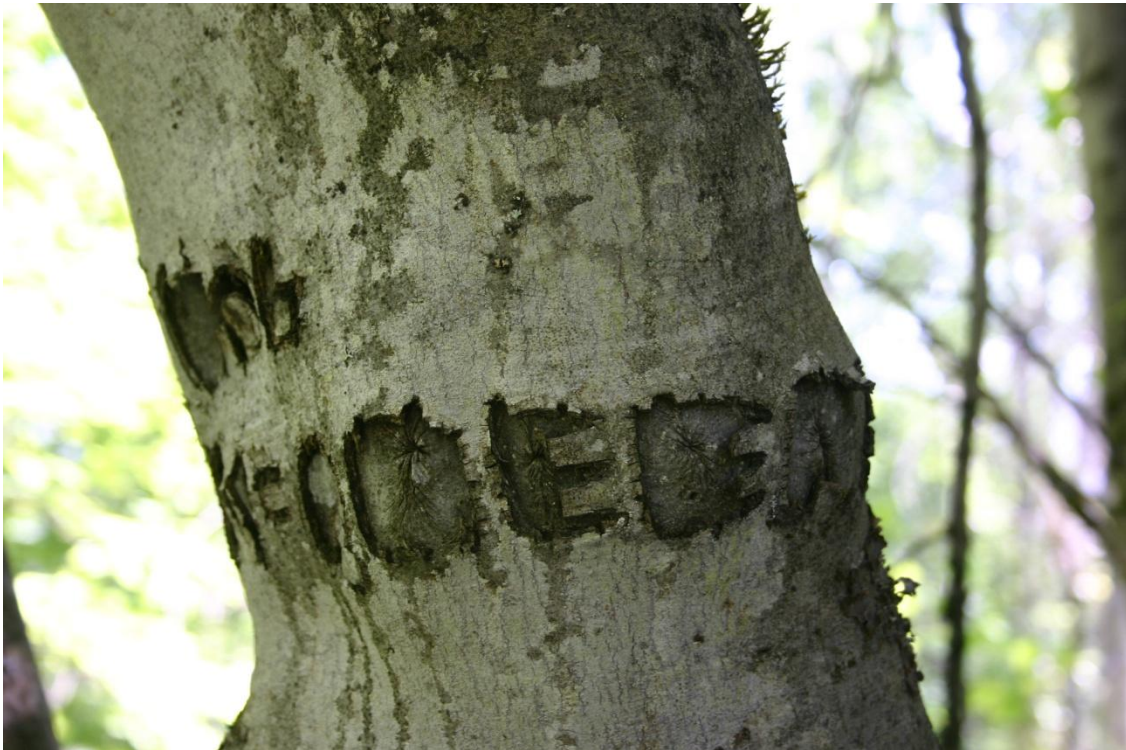
**Figure 22.** The name Rob (or Bob?) McQueen carved into a non-native maple tree. The carving is old enough that new bark has regenerated under the original carving.

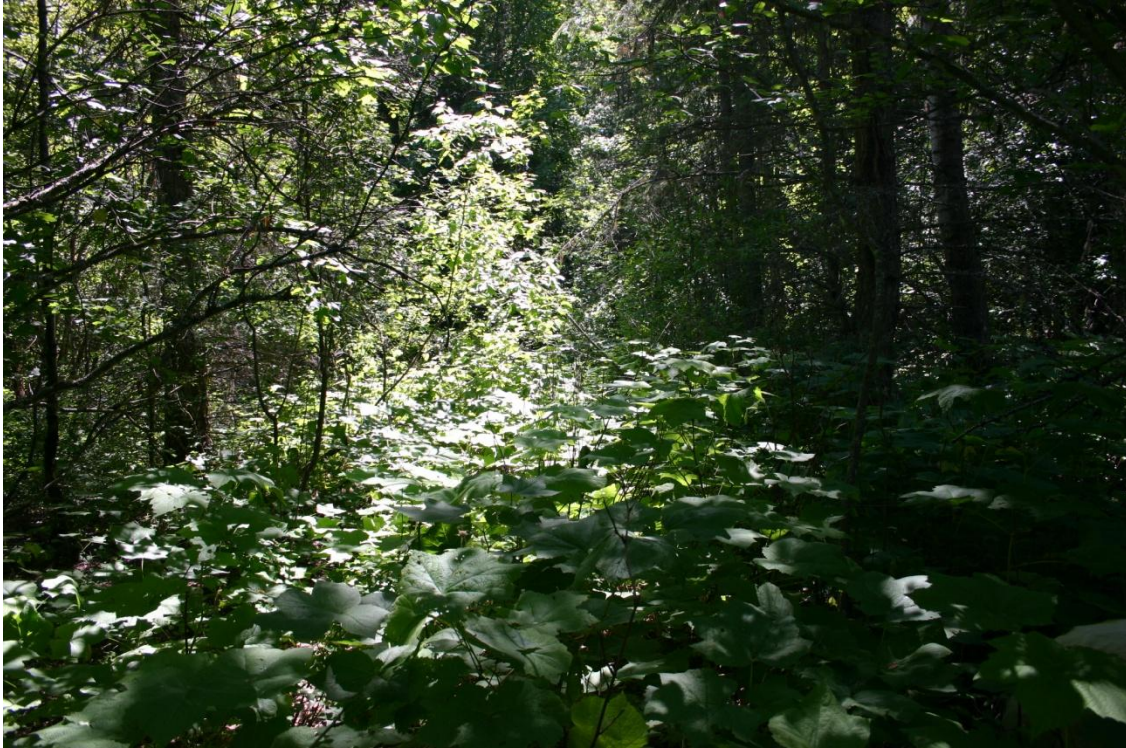
Remaining roads within the townsite are made visible by linear 'openings' which are overgrown with thimbleberry (see Figure 23), a native species which is often the first plant to become established in areas which have seen a high degree of recent soil disturbance, such as landslides, old roadbeds, and old building footprints as observed in the townsite block surveys. Some roads are more overgrown than others, and in addition to the thimbleberry these roads are obscured by other native species which similarly prefer recently disturbed soils. These species include alder, water birch, and strawberry.

**Figure 23.** 8<sup>th</sup> Street, view south from Cook Avenue. The former street is evident in the linear arrangement of thimbleberry, bordered by birch and alder, all native species which tend to grow on disturbed ground (i.e. old roadbeds).

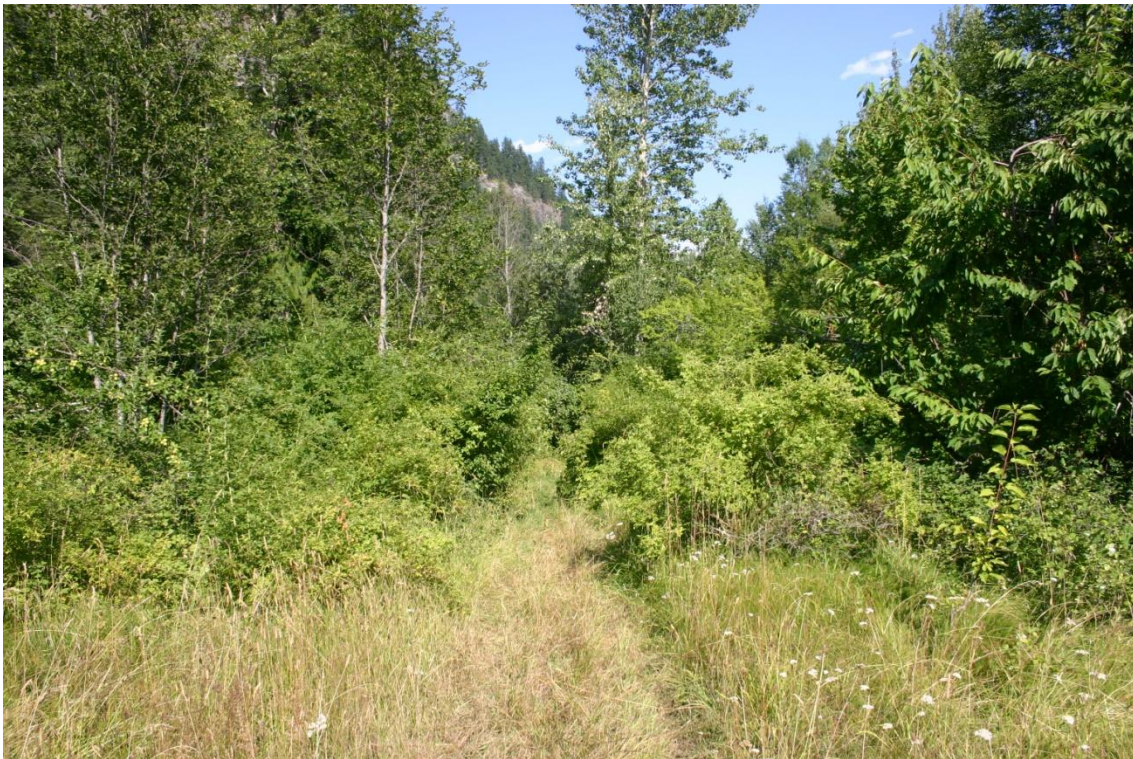
**Figure 24.** Lonsdale Street, facing east from 7<sup>th</sup> Street. Introduced and natural vegetation encroaches from the north and south, and an ATV trail runs up the middle.

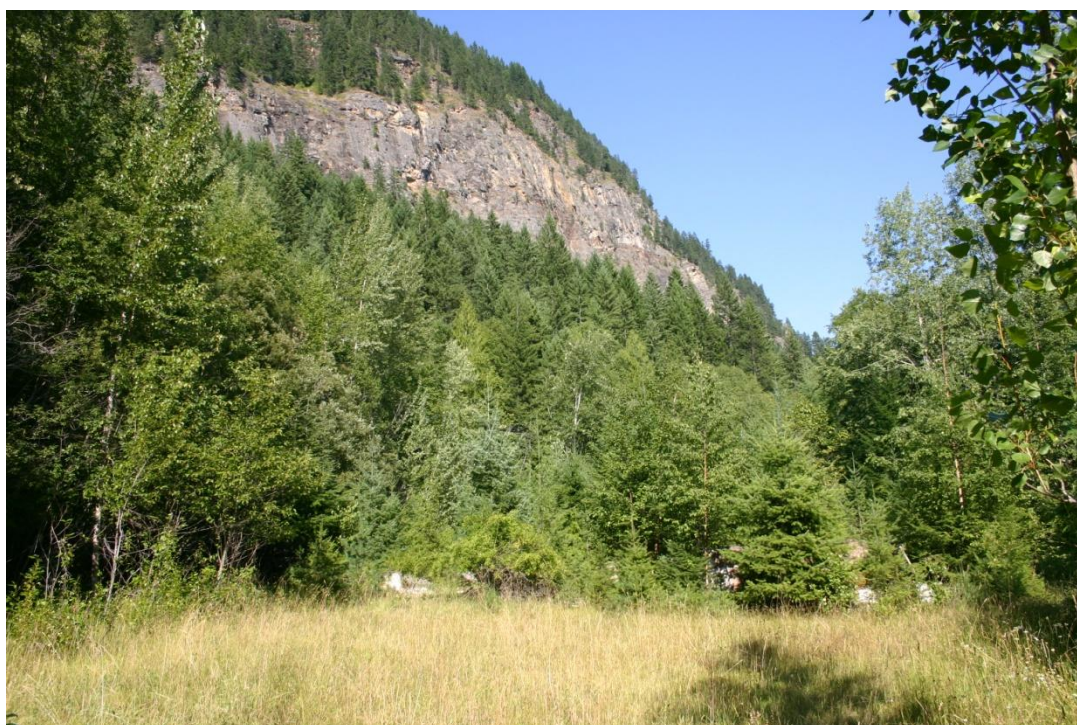
**Figure 26.** The site of the Arrowhead School in 2008. The foundation is obscured by encroaching native vegetation (immature fir trees).

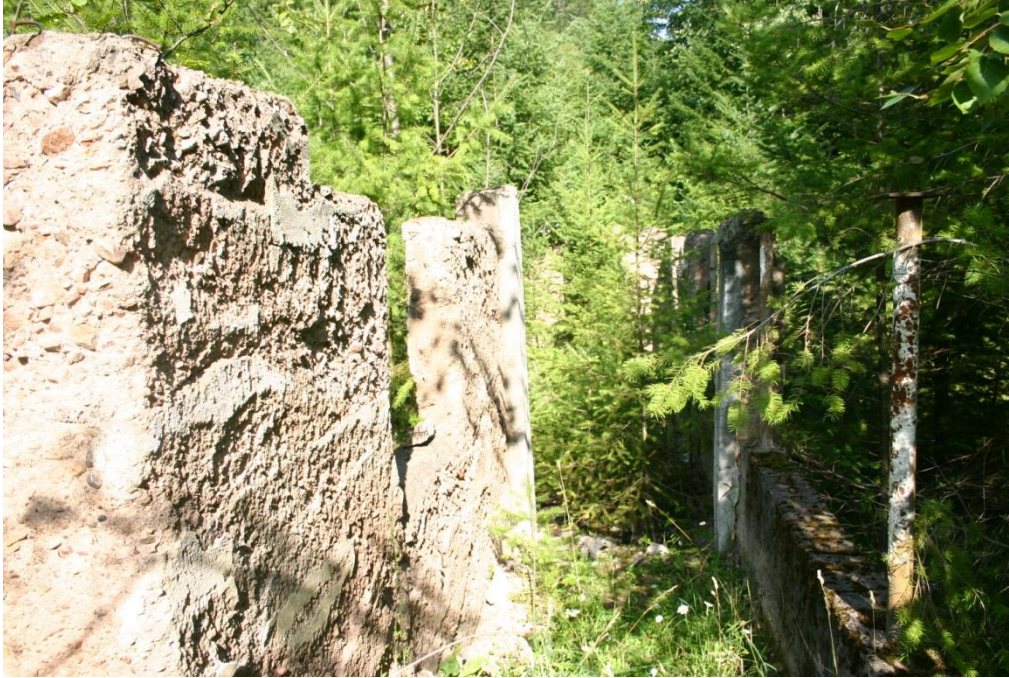
**Figure 27.** An entrance to the basement at the southwest corner of the school, under where the external stairway to the second floor had been. Variations in the colour and texture of the concrete suggest that this doorway and the low wall to the right were later renovations.

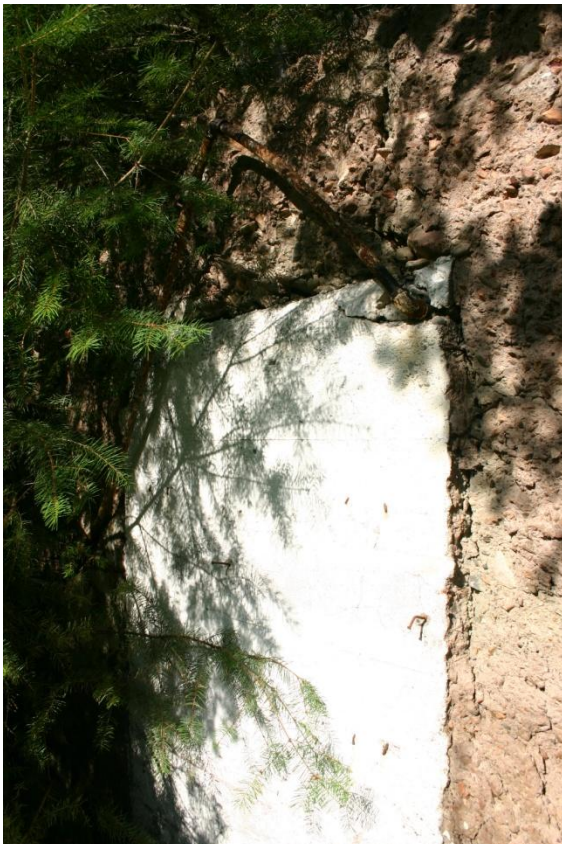
**Figure 28.** A doorway in the west wall of the original foundation was subsequently filled in. A water pipe leads through the former opening to a concrete cistern located east of the school.

To the east of the school is an 8 x 12 foot concrete cistern approximately 7 ½ feet high. The cistern has 6" thick walls and was formed via the shiplap construction method. The top of the cistern is open, with a 6" thick suspended slab approximately 4 feet down from the top. A threaded metal pipe comes down from the bottom of this slab at the western end and out through the wall of the cistern, at which point it connects to a 'T' fitting, on the end of which there must have been a tap which is now missing. A pipe comes off the centre of the 'T' and into the ground. The buried pipe comes into the east wall of the school foundation through the filled-in doorway (see Figure 28).

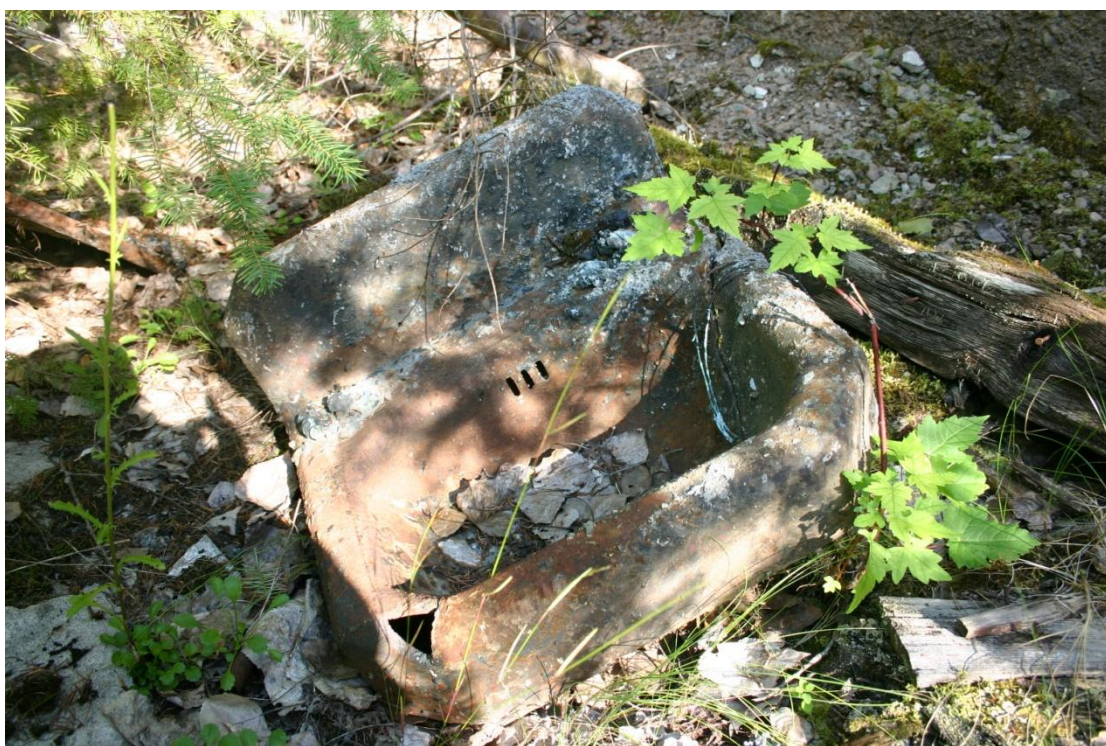
**Figure 30.** The remains of a metal 2-tap sink found inside the foundation near the SE corner. This is near where a water pipe enters the foundation through a filled-in doorway which leads to a cistern west of the building.

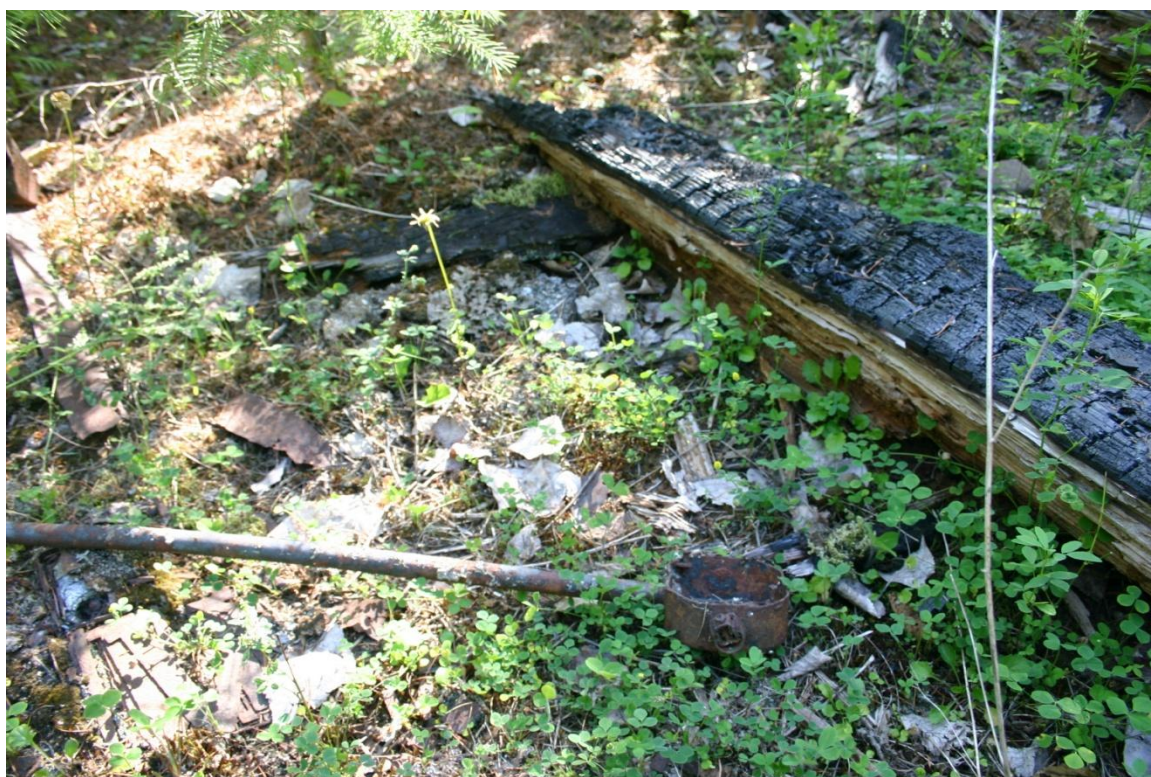
**Figure 32.** Electrical conduit and burnt timber inside the school foundation.

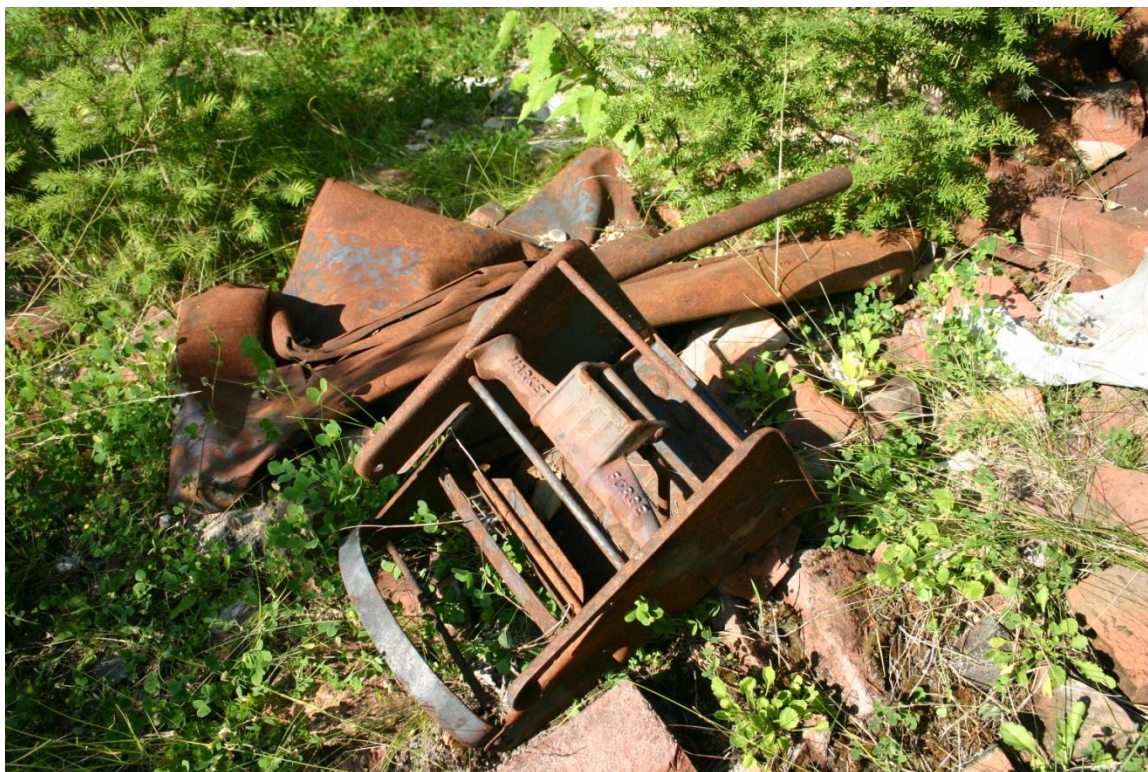
**Figure 33.** The remains of one of two metal bucket-top mop wringers inside the school.

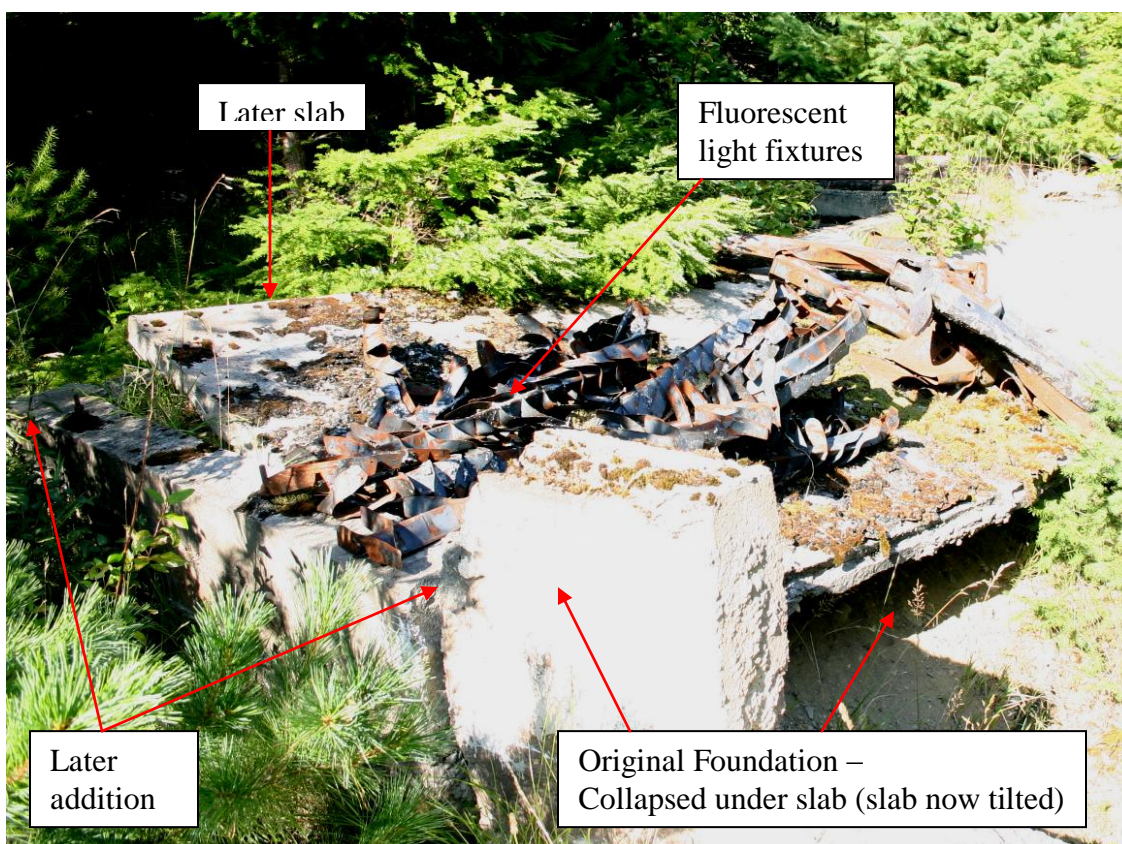
**Figure 34.** Northwest corner of the school foundation showing later modifications.
