# **A HERITAGE RESOURCE ASSESSMENT FOR THE HISTORIC ARROWHEAD TOWNSITE AND CEMETERY, ARROWHEAD, BRITISH COLUMBIA**

**January 15<sup>th</sup>, 2009**

**HORIZON**  
HERITAGE CONSULTING

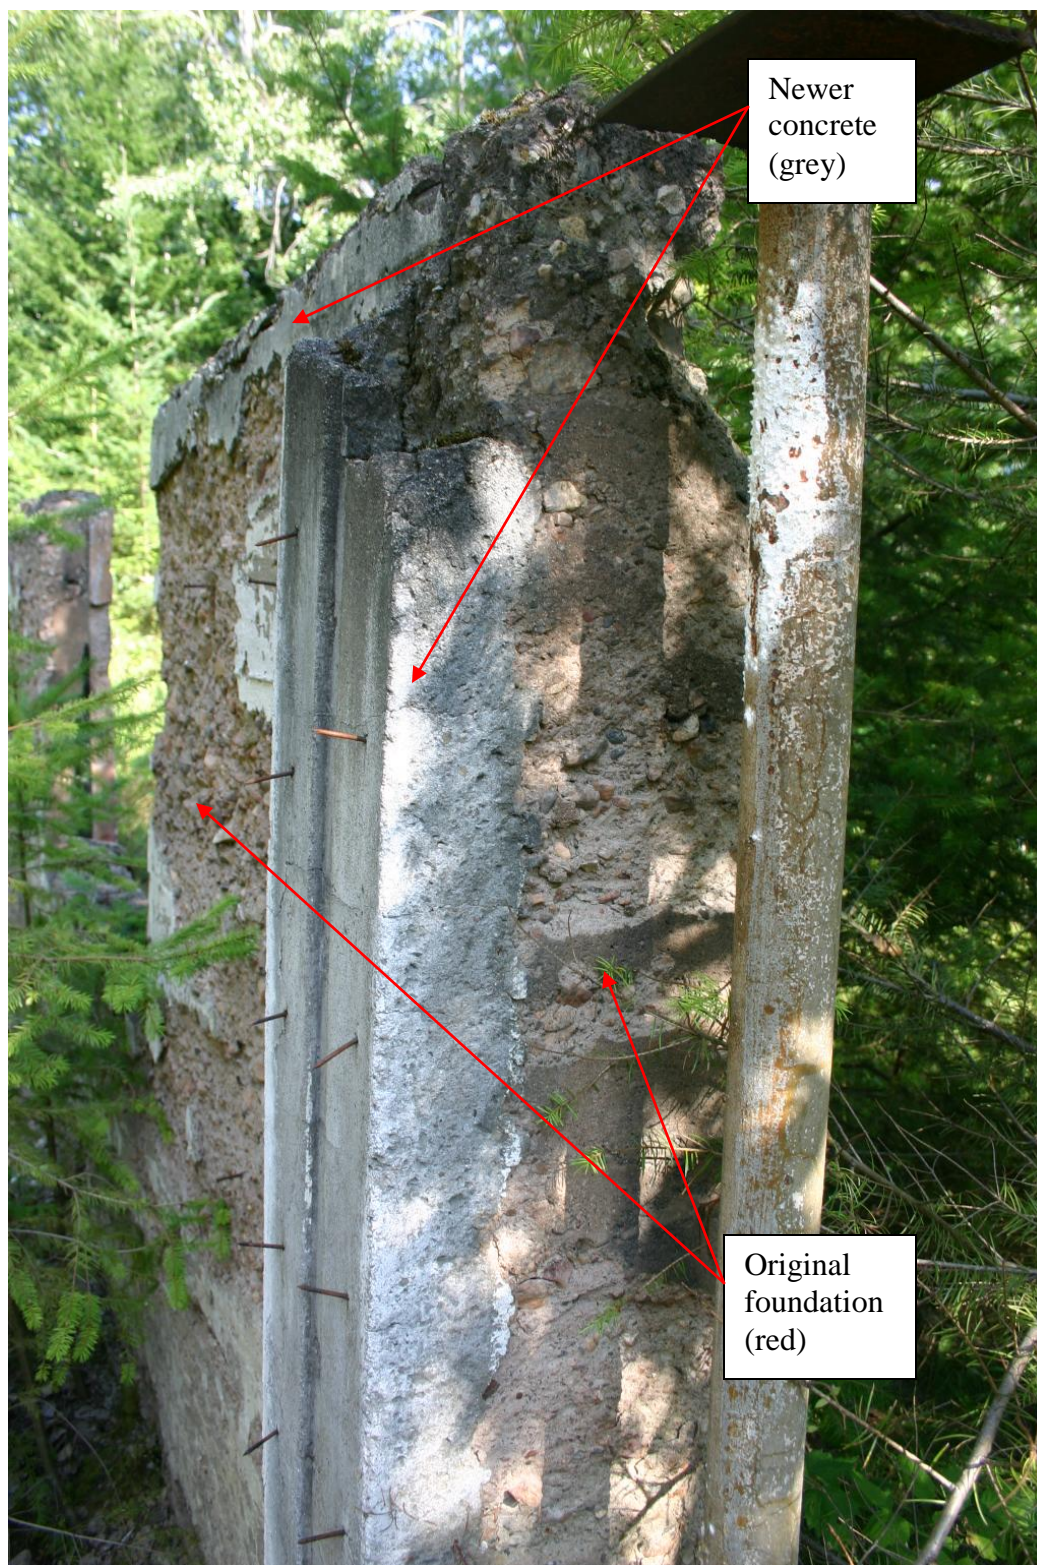
**Figure 35.** Modifications to the southwest corner of the foundation, where it appears a later doorway was added.

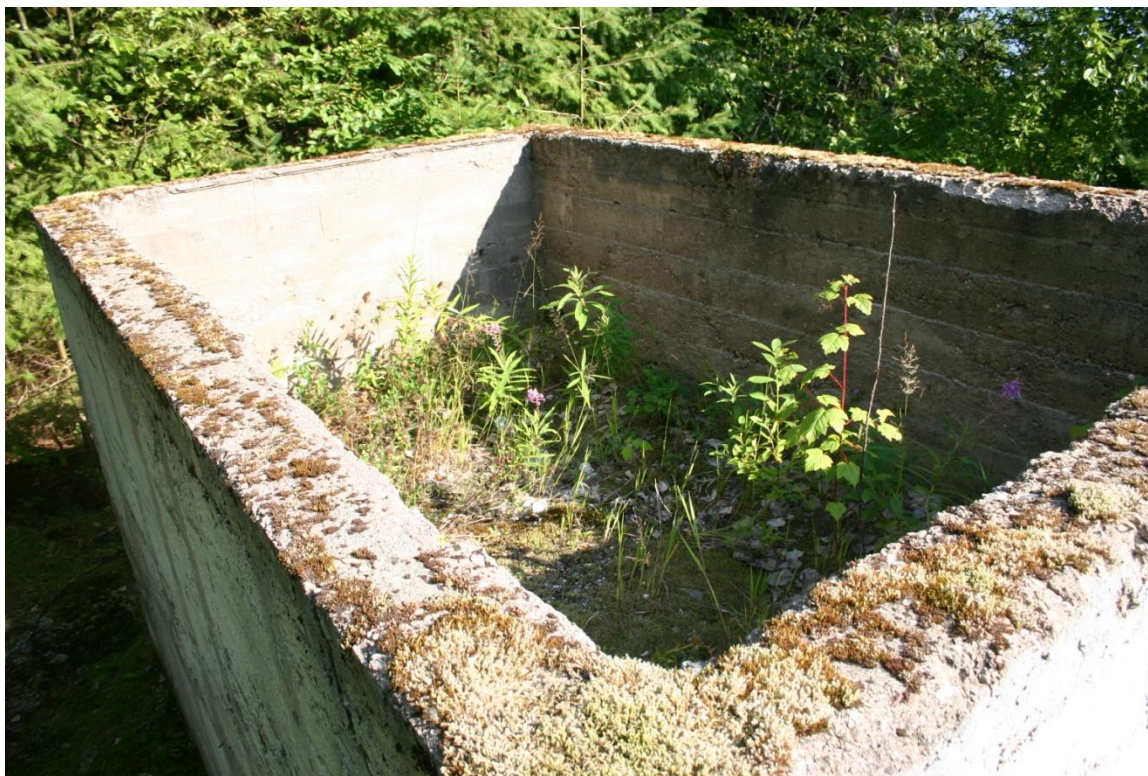
**Figure 36.** The open top of the concrete cistern.

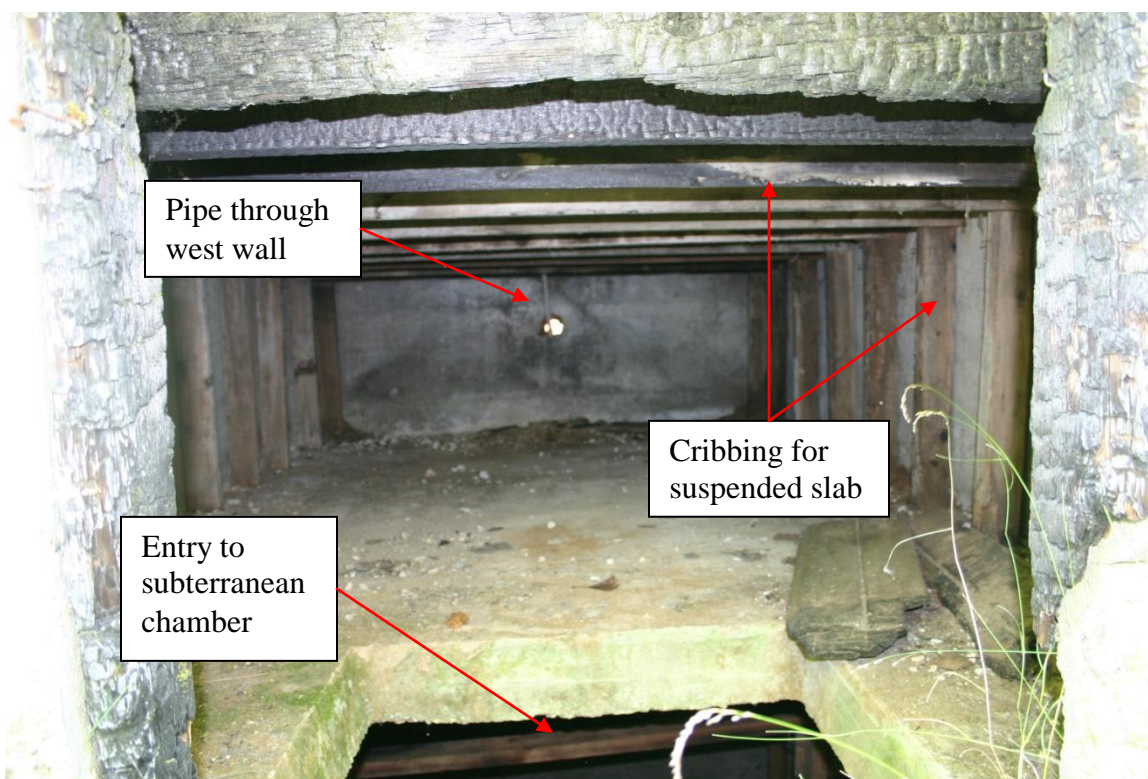
The cribbing for the suspended slab under the upper reservoir is still in place, and can easily be observed through the opening at the east end. Eight-inch shiplap was used, suspended by 2x6" joists which are in turn supported by 2x4" studs on 16" centres which are standing on the lower slab (see Figure 37). Within the subterranean chamber are several scraps of weathered dimensional lumber, and two sets of makeshift plywood shelves (Figure 38).

**Figure 37.** The inside of the cistern at ground level, facing west.

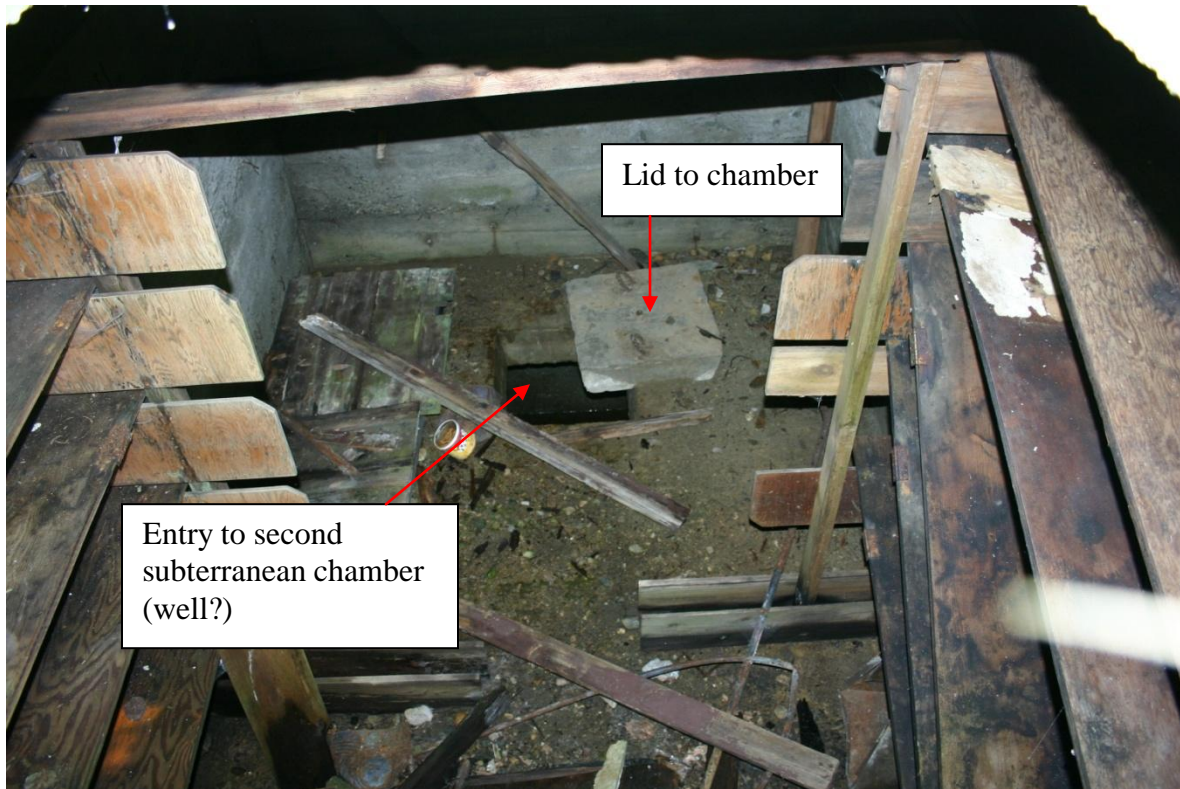
**Figure 38.** The subterranean chamber of the cistern.

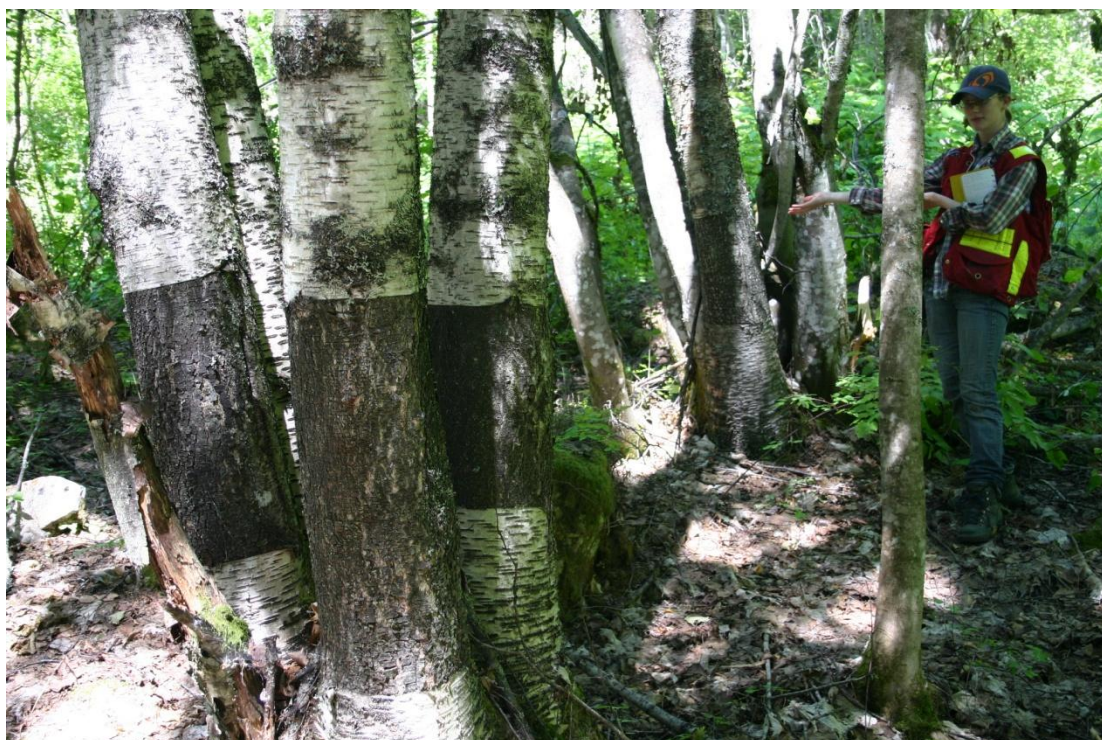
**Figure 54.** Bark-stripped birch Culturally Modified Trees in Block F.
